Intersection ID: 27298	Main Street: CHARTER_HILLS_RD	Cross Street: OWL_NEST_LN	Location:	SW
ADA ID: 8C168B7B94EF	Ramp Type: PerpDiag	Initial Pass/Fail: Fail	Overall Compliance: No	Severity Score: 22.5

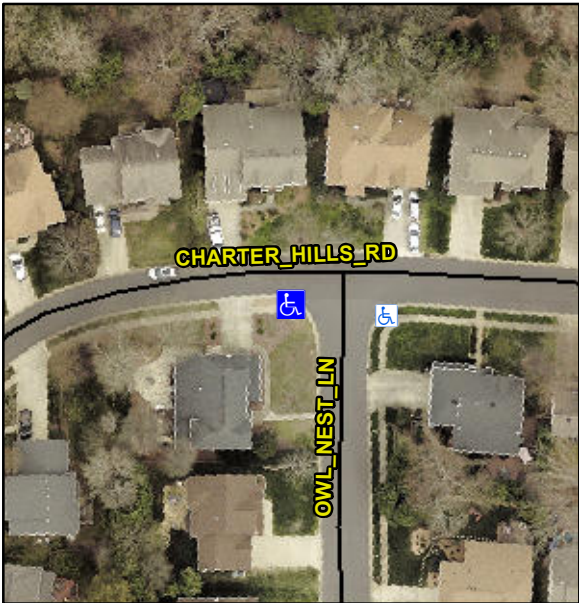
Possible Solutions:			Compliance	Description	Data	Compliance	Description	Data
	Remove & Replace Curb Ramp With Two New Directional Ramps or Equivalent.			N/A	Ramp Length (in)	41.0	No	Ramp Slope (%)	8.9
				No	Ramp Width (in)	46.5	No	Ramp XSlope (%)	2.2
				N/A	Flare Type LT	N/A	N/A	Flare Type RT	N/A
				N/A	Flare Slope LT (%)	N/A	N/A	Flare Slope RT (%)	N/A
				N/A	Flare Traversable LT?	N/A	N/A	Flare Traversable RT?	N/A
				N/A	Landing Length (in)	N/A	N/A	DWS Provided?	N/A
				N/A	Landing Width (in)	N/A	N/A	DWS Contrast?	N/A
				N/A	Landing Slope (%)	N/A	N/A	DWS Length (in)	N/A
				N/A	Landing X Slope (%)	N/A	N/A	DWS Full Width?	N/A
Surveyor Notes:	N/A			N/A	Landing Curb? (Y/N)	N/A	N/A	DWS Offset (in)	N/A
				N/A	Shared Landing?	N/A			
	PROW/ADA:			N/A	Gutter Ponding?	N/A	N/A	Gutter Slope (%)	N/A
	R304.5.1, R304.2.2, R304.5.3			N/A	Gutter Lip Ht (in)	N/A	N/A	Gutter X Slope (%)	N/A

N/A	Painted X Walk1?	No	N/A	Painted X Walk2?	No
					X Walk 1 Direction	To E		X Walk 2 Direction	To NE
				N/A	X Walk 1 Width (in)	N/A	N/A	X Walk 2 Width (in)	N/A
					X Walk 1 Slope (%)	3.9		X Walk 2 Slope (%)	3.5
					X Walk 1 X Slope (%)	4.2		X Walk 2 X Slope (%)	1.9
				N/A	Ramp inside XWalk1?	N/A	N/A	Ramp inside XWalk2?	N/A
Street 1 Name	OWL NEST LN				Road Slope (%)	3.7	N/A	Clear Space?	N/A
	Stop Condition-Street 2				Road X Slope (%)	5.8	N/A	Clear Space to XWalk (in)	N/A
	Street 2 Name				Any Obstructions?	N/A	N/A	Storm Grate/Utility Hazard?	N/A
	Stop Condition-Street 1				Obstruction Type			Storm Grate/Utility Type	
						N/A			N/A
							Yes	Surface Condition? (G/P)	Good
Total Cost:			\$	3200.00
