# Access Compliance Report

## Public Rights-of-Way

### (Curb Ramps)

Intersection ID: 10020680	Main Street: BEAM_RD	Cross Street: N/A	Location: E
ADA ID: 8C22A80F5ED5	Ramp Type: Perp	Initial Pass/Fail: Fail	Overall Compliance: No
Codes/Mitigation Info/Possible Solution		Field Measurements/Component Compliance	
Severity Score: 13.75

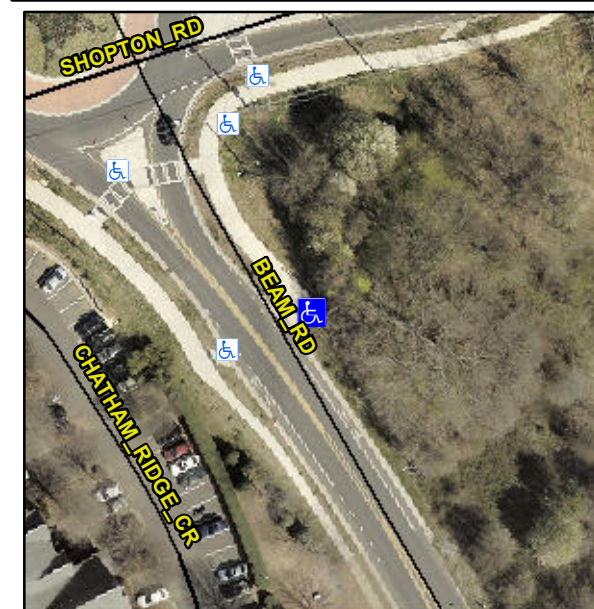
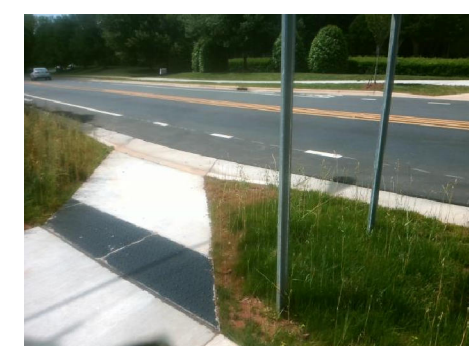
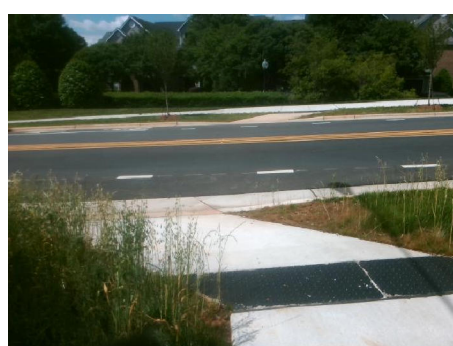
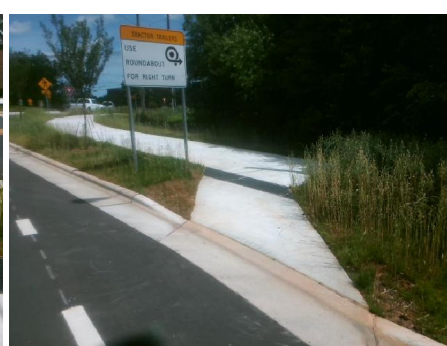
**R304.2.2, R304.5.3**

Compliance	Description	Data	Compliance	Description	Data
N/A	Ramp Length (in)	98.0	No	Ramp Slope (%)	8.9
Yes	Ramp Width (in)	95.0	No	Ramp XSlope (%)	4.9
N/A	Flare Type LT	N/A	N/A	Flare Type RT	N/A
N/A	Flare Slope LT (%)	N/A	N/A	Flare Slope RT (%)	N/A
N/A	Flare Traversable LT?	N/A	N/A	Flare Traversable RT?	N/A
N/A	Landing Length (in)	N/A	N/A	DWS Provided?	N/A
N/A	Landing Width (in)	N/A	N/A	DWS Contrast?	N/A
N/A	Landing Slope (%)	N/A	N/A	DWS Length (in)	N/A
N/A	Landing X Slope (%)	N/A	N/A	DWS Full Width?	N/A
N/A	Landing Curb? (Y/N)	N/A	N/A	DWS Offset (in)	N/A
N/A	Shared Landing?	N/A			
N/A	Gutter Ponding?	N/A	N/A	Gutter Slope (%)	N/A
N/A	Gutter Lip Ht (in)	N/A	N/A	Gutter X Slope (%)	N/A
N/A	Painted X Walk1?	No	N/A	Painted X Walk2?	N/A
	X Walk 1 Direction	To W		X Walk 2 Direction	N/A
N/A	X Walk 1 Width (in)	N/A	N/A	X Walk 2 Width (in)	N/A
	X Walk 1 Slope (%)	2.3		X Walk 2 Slope (%)	N/A
	X Walk 1 X Slope (%)	3.6		X Walk 2 X Slope (%)	N/A

N/A	Ramp inside XWalk1?	N/A	N/A	Ramp inside XWalk2?	N/A
	Road Slope (%)	N/A	N/A	Clear Space?	N/A
	Road X Slope (%)	N/A	N/A	Clear Space to XWalk (in)	N/A
N/A	Any Obstructions?	N/A	N/A	Storm Grate/Utility Hazard?	N/A
	Obstruction Type			Storm Grate/Utility Type	
		N/A			N/A
		Yes		Surface Condition? (G/P)	Good

**Remove & Replace Entire Ramp.**

Total Cost: \$ 1850.00
