Access Compliance Report

Public Rights-of-Way

(Curb Ramps)

| Intersection ID: 20319 | Main Street: INGLEHURST_DR | Cross Street: QUEENSMEAD_CR | Location: | E |

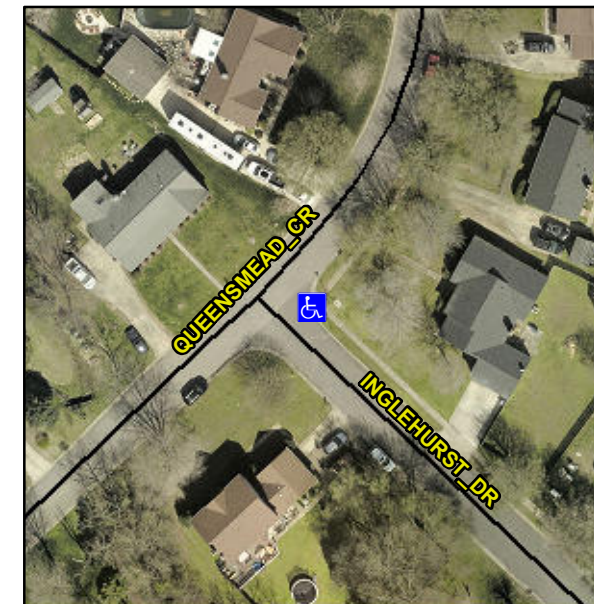
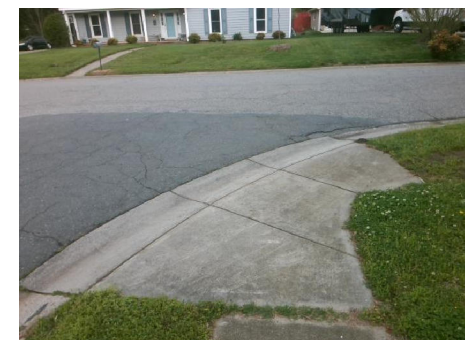
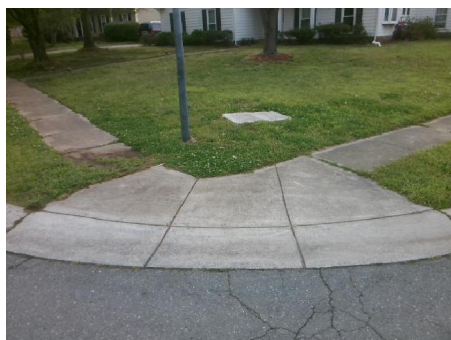
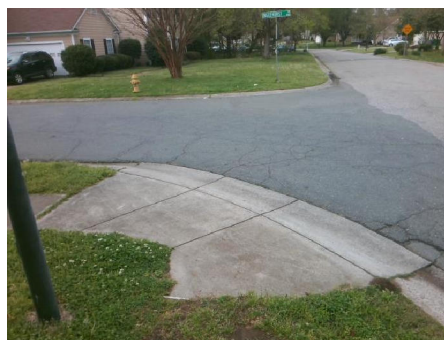
| ADA ID: 8C32888E4846 | Ramp Type: BlendTrans2 | Initial Pass/Fail: Fail | Overall Compliance: No | Severity Score: 10 |

R304.5.1, R304.5.3

| Compliance | Description | Data | Compliance | Description | Data |
|---|---|---|---|---|---|
| No | Ramp Width (in) | 41.0 | No | BlendTrans XSlope (%) | 4.0 |

Remove & Replace Curb Ramp With Two New Directional Ramps or Equivalent.
