# Access Compliance Report

## Public Rights-of-Way

### (Curb Ramps)

Intersection ID: 42769	Main Street: ERWIN_RIDGE_AV	Cross Street: JEANETTE_CR	Location: SW
ADA ID: 8C3498852334	Ramp Type: BlendTrans1	Initial Pass/Fail: Fail	Overall Compliance: No
Severity Score: 21.25			
Codes/Mitigation Info/Possible Solution		Field Measurements/Component Compliance

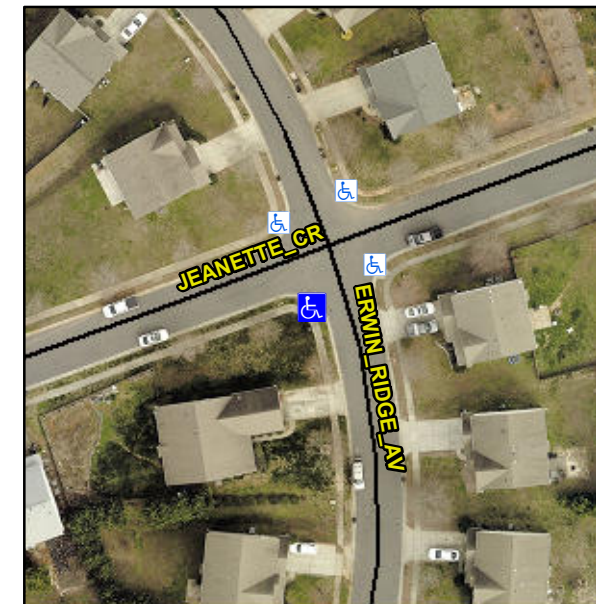
**Not Found, R304.5.1, R304.5.3**

Compliance	Description	Data	Compliance	Description	Data
N/A	Ramp Length (in)	43.0	Yes	BlendTrans Slope (%)	3.3
No	Ramp Width (in)	42.0	No	BlendTrans XSlope (%)	6.9
N/A	Flare Type LT	N/A	N/A	Flare Type RT	N/A
N/A	Flare Slope LT (%)	N/A	N/A	Flare Slope RT (%)	N/A
N/A	Flare Traversable LT?	N/A	N/A	Flare Traversable RT?	N/A
N/A	Landing Length (in)	N/A	N/A	DWS Provided?	N/A
N/A	Landing Width (in)	N/A	N/A	DWS Contrast?	N/A
N/A	Landing Slope (%)	N/A	N/A	DWS Length (in)	N/A
N/A	Landing X Slope (%)	N/A	N/A	DWS Full Width?	N/A
N/A	Landing Curb? (Y/N)	N/A	N/A	DWS Offset (in)	N/A
N/A	Shared Landing?	N/A			
N/A	Gutter Ponding?	N/A	N/A	Gutter Slope (%)	N/A
N/A	Gutter Lip Ht (in)	N/A	N/A	Gutter X Slope (%)	N/A
N/A	Painted X Walk1?	No	N/A	Painted X Walk2?	No
	X Walk 1 Direction	To NE		X Walk 2 Direction	To NW
	X Walk 1 Width (in)	N/A		X Walk 2 Width (in)	N/A
	X Walk 1 Slope (%)	0.9		X Walk 2 Slope (%)	4.5
	X Walk 1 X Slope (%)	5.6		X Walk 2 X Slope (%)	1.0

N/A	Ramp inside XWalk1?	N/A	N/A	Ramp inside XWalk2?	N/A
	Road Slope (%)	4.9		Clear Space?	N/A
	Road X Slope (%)	4.8	N/A	Clear Space to XWalk (in)	N/A
N/A	Any Obstructions?	N/A	N/A	Storm Grate/Utility Hazard?	N/A
	Obstruction Type			Storm Grate/Utility Type	
		N/A			N/A
			Yes	Surface Condition? (G/P)	Good
			No	Curb Slope (%)	12.7

**Remove & Replace Curb Ramp With Two New Directional Ramps or Equivalent.**

Total Cost: \$ 3200.00
