# Access Compliance Report

## Public Rights-of-Way

### (Curb Ramps)

Intersection ID: 44907	Main Street: OAK_DR	Cross Street: OAKWINDS_CT	Location: SW
ADA ID: 8C4A52840974	Ramp Type: Perp	Initial Pass/Fail: Fail	Overall Compliance: No
			Severity Score: 33.75

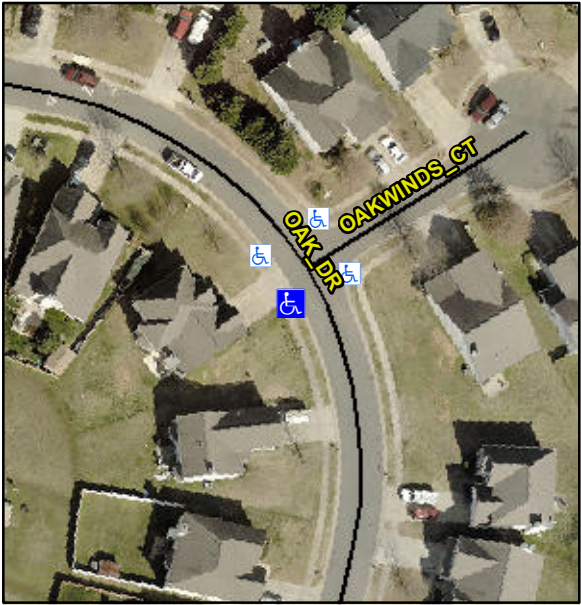
Possible Solutions:		<b>Compliance</b>	<b>Description</b>	<b>Data</b>
	<b>Remove &amp; Replace Entire Ramp.</b>		<b>No</b>	Ramp Length (in)	47.0
			<b>No</b>	Ramp Width (in)	37.0
			<b>N/A</b>	Flare Type LT	N/A
			<b>N/A</b>	Flare Slope LT (%)	N/A
			<b>N/A</b>	Flare Traversable LT?	N/A
			<b>N/A</b>	Landing Length (in)	N/A
			<b>N/A</b>	Landing Width (in)	N/A
			<b>N/A</b>	Landing Slope (%)	N/A
			<b>N/A</b>	Landing X Slope (%)	N/A
<p>Surveyor Notes:</p> <p><b>N/A</b></p> <p>PROW/ADA:</p> <p><b>Not Found, R304.5.1, R304.2.2, R304.5.3</b></p>			<b>N/A</b>	Flare Type RT	N/A
			<b>N/A</b>	Flare Slope RT (%)	N/A
			<b>N/A</b>	Flare Traversable RT?	N/A
			<b>N/A</b>	DWS Provided?	N/A
			<b>N/A</b>	DWS Contrast?	N/A
			<b>N/A</b>	DWS Length (in)	N/A
			<b>N/A</b>	DWS Full Width?	N/A
			<b>N/A</b>	DWS Offset (in)	N/A
			<b>N/A</b>	Gutter Ponding?	N/A

<b>N/A</b>	Gutter Lip Ht (in)	N/A
			<b>No</b>	Painted X Walk1?	N/A
				X Walk 1 Direction	To NE
			<b>N/A</b>	X Walk 1 Width (in)	N/A
				X Walk 1 Slope (%)	2.3
				X Walk 1 X Slope (%)	7.4
			<b>N/A</b>	Ramp inside XWalk1?	N/A
			<b>N/A</b>	Road Slope (%)	N/A
			<b>N/A</b>	Road X Slope (%)	N/A
			<b>N/A</b>	Any Obstructions?	N/A
				Obstruction Type	
Total Cost:		\$ 1850.00	<b>N/A</b>		
			<b>Yes</b>	Surface Condition? (G/P)	Good
