Access Compliance Report

Public Rights-of-Way

(Curb Ramps)

Intersection ID: 42727	Main Street: SPEEDWELL_CT	Cross Street: PICKEREL_LN	Location: E
ADA ID: 8C4D7D6F97B5	Ramp Type: Perp	Initial Pass/Fail: Fail	Overall Compliance: No
Codes/Mitigation Info/Possible Solution		Field Measurements/Component Compliance	
Severity Score: 13.75

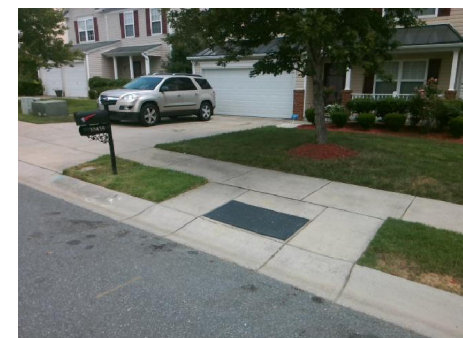
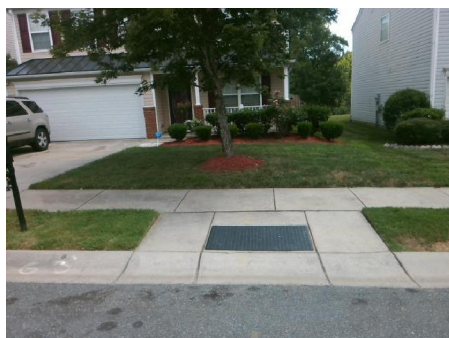
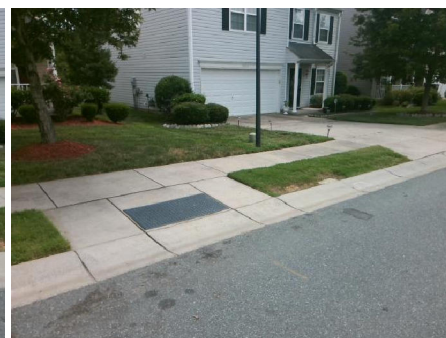
Not Found, R304.2.2, R304.5.3

Compliance	Description	Data	Compliance	Description	Data
N/A	Ramp Length (in)	48.0	No	Ramp Slope (%)	8.5
Yes	Ramp Width (in)	49.0	No	Ramp XSlope (%)	2.8
N/A	Flare Type LT	N/A	N/A	Flare Type RT	N/A
N/A	Flare Slope LT (%)	N/A	N/A	Flare Slope RT (%)	N/A
N/A	Flare Traversable LT?	N/A	N/A	Flare Traversable RT?	N/A
N/A	Landing Length (in)	N/A	N/A	DWS Provided?	N/A
N/A	Landing Width (in)	N/A	N/A	DWS Contrast?	N/A
N/A	Landing Slope (%)	N/A	N/A	DWS Length (in)	N/A
N/A	Landing X Slope (%)	N/A	N/A	DWS Full Width?	N/A
N/A	Landing Curb? (Y/N)	N/A	N/A	DWS Offset (in)	N/A
N/A	Shared Landing?	N/A			
N/A	Gutter Ponding?	N/A	N/A	Gutter Slope (%)	N/A
N/A	Gutter Lip Ht (in)	N/A	N/A	Gutter X Slope (%)	N/A
N/A	Painted X Walk1?	No	N/A	Painted X Walk2?	N/A
	X Walk 1 Direction	To NW		X Walk 2 Direction	N/A
N/A	X Walk 1 Width (in)	N/A	N/A	X Walk 2 Width (in)	N/A
	X Walk 1 Slope (%)	5.6		X Walk 2 Slope (%)	N/A
	X Walk 1 X Slope (%)	1.4		X Walk 2 X Slope (%)	N/A

N/A	Ramp inside XWalk1?	N/A	N/A	Ramp inside XWalk2?	N/A
	Road Slope (%)	N/A	N/A	Clear Space?	N/A
	Road X Slope (%)	N/A	N/A	Clear Space to XWalk (in)	N/A
N/A	Any Obstructions?	N/A	N/A	Storm Grate/Utility Hazard?	N/A
	Obstruction Type			Storm Grate/Utility Type	
		N/A			N/A
			Yes	Surface Condition? (G/P)	Good

Remove & Replace Entire Ramp.
