Access Compliance Report

Public Rights-of-Way

(Curb Ramps)

Intersection ID: 44118	Main Street: CORAM_PL	Cross Street: RIDING_HILL_AV	Location:	N
ADA ID: 8C54F24E99FB	Ramp Type: PerpDiag	Initial Pass/Fail: Fail	Overall Compliance: No	Severity Score: 42.5
Codes/Mitigation Info/Possible Solution		Field Measurements/Component Compliance

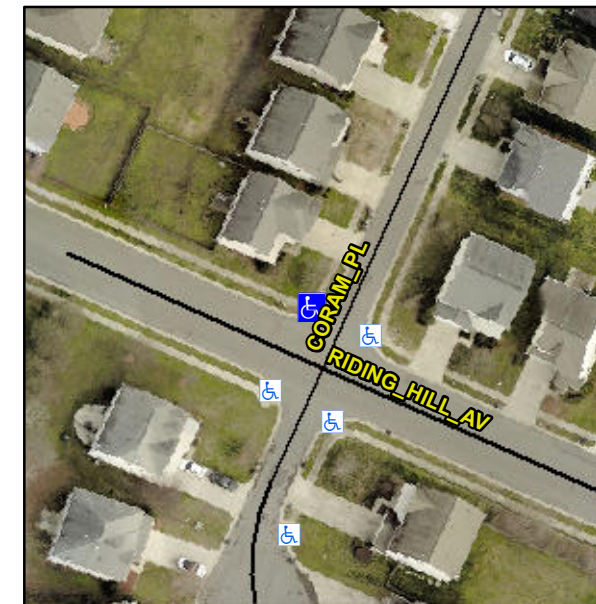
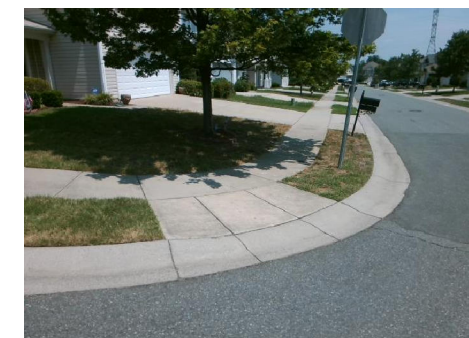
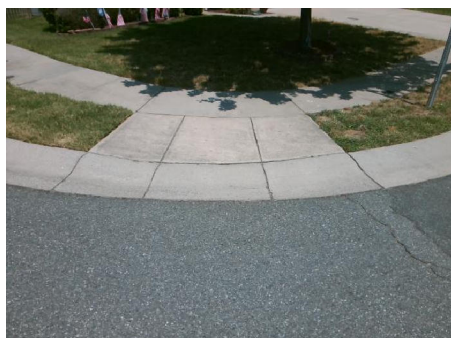
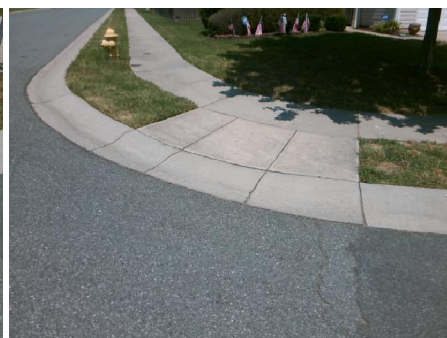
Not Found, R304.5.1, R304.5.3

Compliance	Description	Data	Compliance	Description	Data
N/A	Ramp Length (in)	48.0	Yes	Ramp Slope (%)	6.4
No	Ramp Width (in)	34.0	No	Ramp XSlope (%)	8.2
N/A	Flare Type LT	N/A	N/A	Flare Type RT	N/A
N/A	Flare Slope LT (%)	N/A	N/A	Flare Slope RT (%)	N/A
N/A	Flare Traversable LT?	N/A	N/A	Flare Traversable RT?	N/A
N/A	Landing Length (in)	N/A	N/A	DWS Provided?	N/A
N/A	Landing Width (in)	N/A	N/A	DWS Contrast?	N/A
N/A	Landing Slope (%)	N/A	N/A	DWS Length (in)	N/A
N/A	Landing X Slope (%)	N/A	N/A	DWS Full Width?	N/A
N/A	Landing Curb? (Y/N)	N/A	N/A	DWS Offset (in)	N/A
N/A	Shared Landing?	N/A			
N/A	Gutter Ponding?	N/A	N/A	Gutter Slope (%)	N/A
N/A	Gutter Lip Ht (in)	N/A	N/A	Gutter X Slope (%)	N/A
N/A	Painted X Walk1?	No	N/A	Painted X Walk2?	No
	X Walk 1 Direction	To SW		X Walk 2 Direction	To SE
N/A	X Walk 1 Width (in)	N/A	N/A	X Walk 2 Width (in)	N/A
	X Walk 1 Slope (%)	5.7		X Walk 2 Slope (%)	0.9
	X Walk 1 X Slope (%)	6.6		X Walk 2 X Slope (%)	5.3

N/A	Ramp inside XWalk1?	N/A	N/A	Ramp inside XWalk2?	N/A
	Road Slope (%)	6.3	N/A	Clear Space?	N/A
	Road X Slope (%)	3.4	N/A	Clear Space to XWalk (in)	N/A
N/A	Any Obstructions?	N/A	N/A	Storm Grate/Utility Hazard?	N/A
	Obstruction Type			Storm Grate/Utility Type	
		N/A			N/A
			Yes	Surface Condition? (G/P)	Good

Remove & Replace Curb Ramp With Two New Directional Ramps or Equivalent.

Total Cost: \$ 3200.00
