# Access Compliance Report

## Public Rights-of-Way

### (Curb Ramps)

Intersection ID: 11873	Main Street: PLOTT_RD	Cross Street: VAN_DE_ROHE_DR	Location: S
ADA ID: 8C636B3299EA	Ramp Type: BlendTrans1	Initial Pass/Fail: Fail	Overall Compliance: No
Severity Score: 33.75

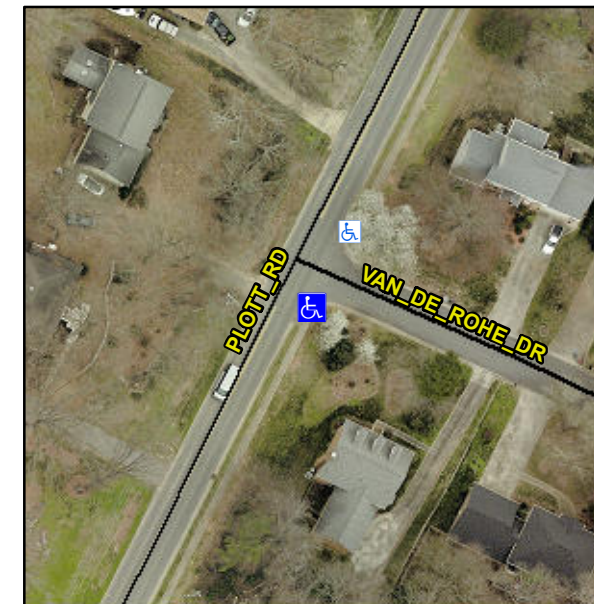
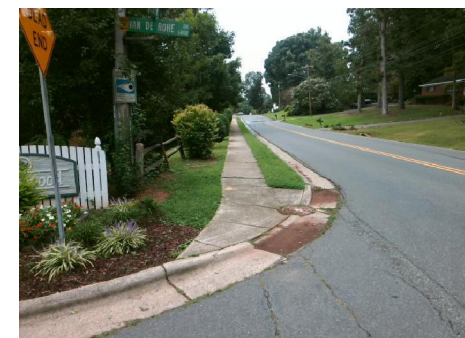
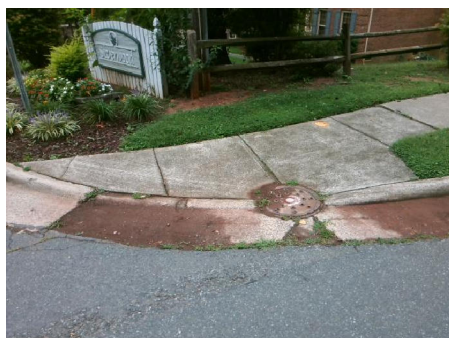
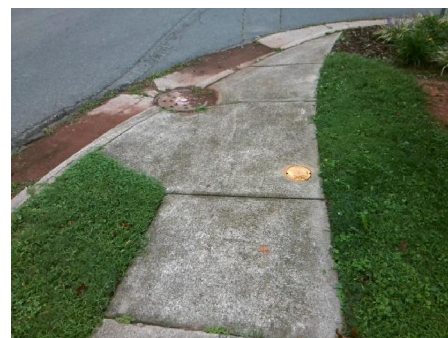
**Not Found, R304.5.1, R304.5.3**

Compliance	Description	Data	Compliance	Description	Data
N/A	Ramp Length (in)	94.0	Yes	BlendTrans Slope (%)	3.2
No	Ramp Width (in)	40.0	No	BlendTrans XSlope (%)	11.3
N/A	Flare Type LT	N/A	N/A	Flare Type RT	N/A
N/A	Flare Slope LT (%)	N/A	N/A	Flare Slope RT (%)	N/A
N/A	Flare Traversable LT?	N/A	N/A	Flare Traversable RT?	N/A
N/A	Landing Length (in)	N/A	N/A	DWS Provided?	N/A
N/A	Landing Width (in)	N/A	N/A	DWS Contrast?	N/A
N/A	Landing Slope (%)	N/A	N/A	DWS Length (in)	N/A
N/A	Landing X Slope (%)	N/A	N/A	DWS Full Width?	N/A
N/A	Landing Curb? (Y/N)	N/A	N/A	DWS Offset (in)	N/A
N/A	Shared Landing?	N/A			
N/A	Gutter Ponding?	N/A	N/A	Gutter Slope (%)	N/A
N/A	Gutter Lip Ht (in)	1.0	N/A	Gutter X Slope (%)	N/A
N/A	Painted X Walk1?	No	N/A	Painted X Walk2?	N/A
	X Walk 1 Direction	To NE		X Walk 2 Direction	N/A
	X Walk 1 Width (in)	N/A		X Walk 2 Width (in)	N/A
	X Walk 1 Slope (%)	0.7		X Walk 2 Slope (%)	N/A
	X Walk 1 X Slope (%)	2.2		X Walk 2 X Slope (%)	N/A

N/A	Ramp inside XWalk1?	N/A	N/A	Ramp inside XWalk2?	N/A
	Road Slope (%)	2.2		Clear Space?	N/A
	Road X Slope (%)	0.7	N/A	Clear Space to XWalk (in)	N/A
N/A	Any Obstructions?	N/A	N/A	Storm Grate/Utility Hazard?	N/A
	Obstruction Type			Storm Grate/Utility Type	
		N/A			N/A
			Yes	Surface Condition? (G/P)	Good
			No	Curb Slope (%)	22.6

**Remove & Replace Curb Ramp With Two New Directional Ramps or Equivalent.**

Total Cost: \$ 3200.00
