Access Compliance Report

Public Rights-of-Way

(Curb Ramps)

Intersection ID: 29268	Main Street: POINTER_RIDGE_DR	Cross Street: SEEDLING_LN	Location: S
ADA ID: 8C65018E77DE	Ramp Type: PerpDiag	Initial Pass/Fail: Fail	Overall Compliance: No
Codes/Mitigation Info/Possible Solution		Field Measurements/Component Compliance

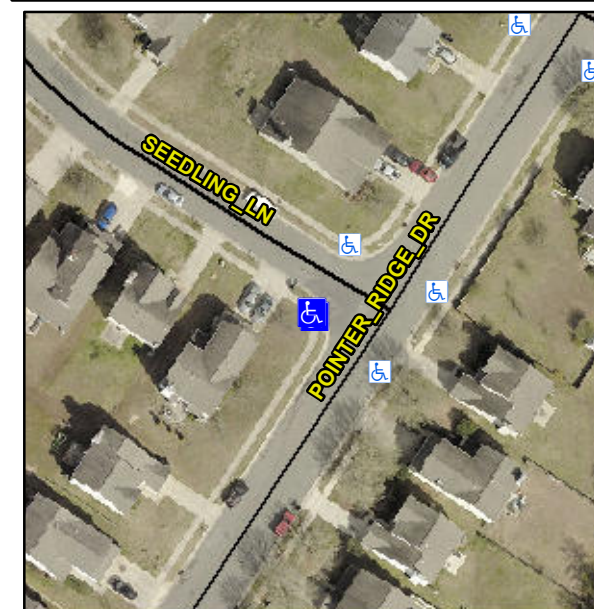
Not Found, R304.5.1, R304.5.3

Compliance	Description	Data	Compliance	Description	Data
N/A	Ramp Length (in)	48.0	Yes	Ramp Slope (%)	5.1
No	Ramp Width (in)	45.0	No	Ramp XSlope (%)	5.9
N/A	Flare Type LT	N/A	N/A	Flare Type RT	N/A
N/A	Flare Slope LT (%)	N/A	N/A	Flare Slope RT (%)	N/A
N/A	Flare Traversable LT?	N/A	N/A	Flare Traversable RT?	N/A
N/A	Landing Length (in)	N/A	N/A	DWS Provided?	N/A
N/A	Landing Width (in)	N/A	N/A	DWS Contrast?	N/A
N/A	Landing Slope (%)	N/A	N/A	DWS Length (in)	N/A
N/A	Landing X Slope (%)	N/A	N/A	DWS Full Width?	N/A
N/A	Landing Curb? (Y/N)	N/A	N/A	DWS Offset (in)	N/A
N/A	Shared Landing?	N/A			
N/A	Gutter Ponding?	N/A	N/A	Gutter Slope (%)	N/A
N/A	Gutter Lip Ht (in)	N/A	N/A	Gutter X Slope (%)	N/A
N/A	Painted X Walk1?	No	N/A	Painted X Walk2?	No
	X Walk 1 Direction	To NW		X Walk 2 Direction	To NE
N/A	X Walk 1 Width (in)	N/A	N/A	X Walk 2 Width (in)	N/A
	X Walk 1 Slope (%)	2.0		X Walk 2 Slope (%)	5.6
	X Walk 1 X Slope (%)	6.6		X Walk 2 X Slope (%)	3.1

N/A	Ramp inside XWalk1?	N/A	N/A	Ramp inside XWalk2?	N/A
	Road Slope (%)	3.2	N/A	Clear Space?	N/A
	Road X Slope (%)	6.4	N/A	Clear Space to XWalk (in)	N/A
N/A	Any Obstructions?	N/A	N/A	Storm Grate/Utility Hazard?	N/A
	Obstruction Type			Storm Grate/Utility Type	
		N/A			N/A
			Yes	Surface Condition? (G/P)	Good

Remove & Replace Curb Ramp With Two New Directional Ramps or Equivalent.
