Access Compliance Report

Public Rights-of-Way

(Curb Ramps)

Intersection ID: 20563	Main Street: FARMHURST_DR	Cross Street: NATIONS_FORD_RD	Location: SE
ADA ID: 8C6B30831F99	Ramp Type: PerpDiag	Initial Pass/Fail: Fail	Overall Compliance: No
Severity Score: 35			
Codes/Mitigation Info/Possible Solution		Field Measurements/Component Compliance

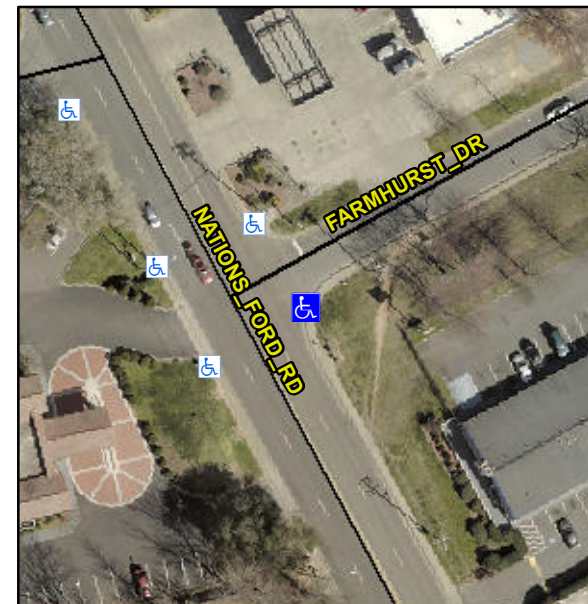
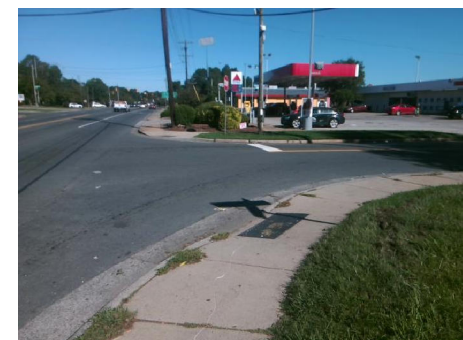
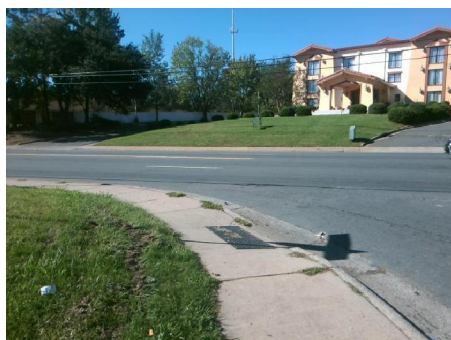
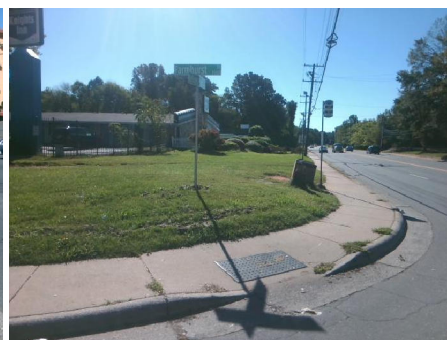
R304.5.1, R304.2.2, R304.5.3

Compliance	Description	Data	Compliance	Description	Data
N/A	Ramp Length (in)	56.0	No	Ramp Slope (%)	14.6
No	Ramp Width (in)	42.0	No	Ramp XSlope (%)	2.3
N/A	Flare Type LT	N/A	N/A	Flare Type RT	N/A
N/A	Flare Slope LT (%)	N/A	N/A	Flare Slope RT (%)	N/A
N/A	Flare Traversable LT?	N/A	N/A	Flare Traversable RT?	N/A
N/A	Landing Length (in)	N/A	N/A	DWS Provided?	N/A
N/A	Landing Width (in)	N/A	N/A	DWS Contrast?	N/A
N/A	Landing Slope (%)	N/A	N/A	DWS Length (in)	N/A
N/A	Landing X Slope (%)	N/A	N/A	DWS Full Width?	N/A
N/A	Landing Curb? (Y/N)	N/A	N/A	DWS Offset (in)	N/A
N/A	Shared Landing?	N/A			
N/A	Gutter Ponding?	N/A	N/A	Gutter Slope (%)	N/A
N/A	Gutter Lip Ht (in)	N/A	N/A	Gutter X Slope (%)	N/A
N/A	Painted X Walk1?	No	N/A	Painted X Walk2?	No
	X Walk 1 Direction	To N		X Walk 2 Direction	To W
N/A	X Walk 1 Width (in)	N/A	N/A	X Walk 2 Width (in)	N/A
	X Walk 1 Slope (%)	2.1		X Walk 2 Slope (%)	2.8
	X Walk 1 X Slope (%)	1.7		X Walk 2 X Slope (%)	0.3

N/A	Ramp inside XWalk1?	N/A	N/A	Ramp inside XWalk2?	N/A
	Road Slope (%)	0.2	N/A	Clear Space?	N/A
	Road X Slope (%)	3.9	N/A	Clear Space to XWalk (in)	N/A
N/A	Any Obstructions?	N/A	N/A	Storm Grate/Utility Hazard?	N/A
	Obstruction Type			Storm Grate/Utility Type	
		N/A			N/A
			Yes	Surface Condition? (G/P)	Good

Remove & Replace Curb Ramp With Two New Directional Ramps or Equivalent.

Total Cost: \$ **3200.00**
