# Access Compliance Report

## Public Rights-of-Way

### (Curb Ramps)

Intersection ID: 45488	Main Street: CAPTAIN_ARDREY_RD	Cross Street: GINHOUSE_LN	Location:	E
ADA ID: 8C6EE21563F0	Ramp Type: PerpDiag	Initial Pass/Fail: Fail	Overall Compliance: No	Severity Score: 22.5
Codes/Mitigation Info/Possible Solution		Field Measurements/Component Compliance

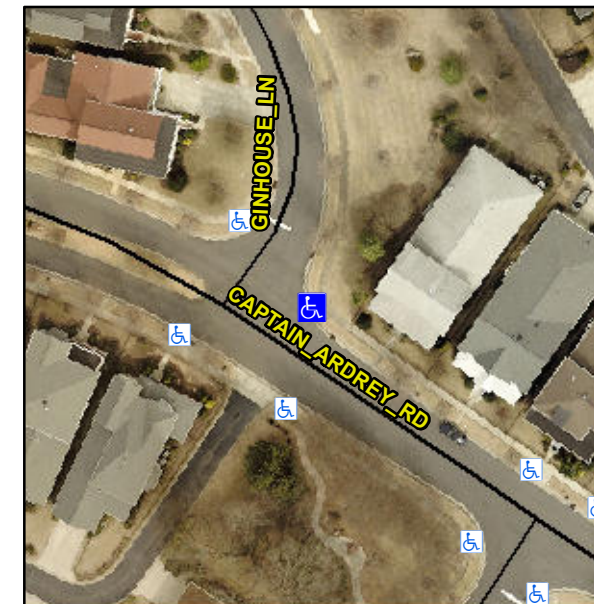
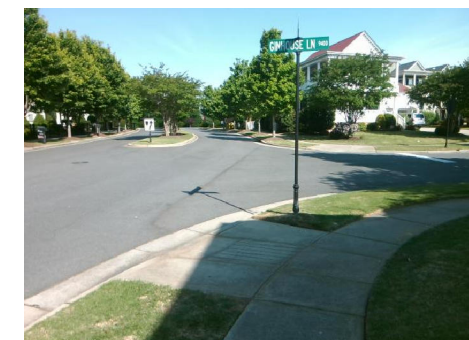
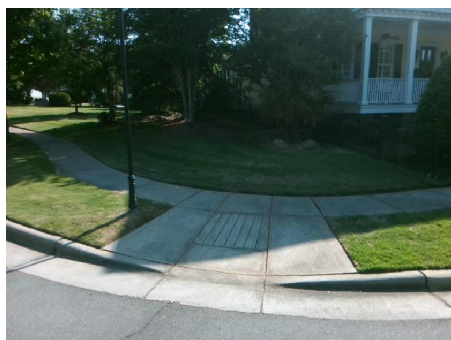
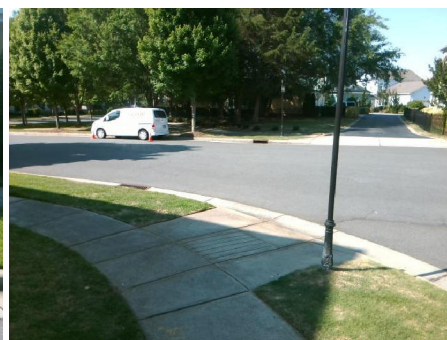
**Not Found, R304.5.1, R304.2.2, R304.5.3**

Compliance	Description	Data	Compliance	Description	Data
N/A	Ramp Length (in)	72.0	No	Ramp Slope (%)	9.5
No	Ramp Width (in)	37.0	No	Ramp XSlope (%)	2.2
N/A	Flare Type LT	N/A	N/A	Flare Type RT	N/A
N/A	Flare Slope LT (%)	N/A	N/A	Flare Slope RT (%)	N/A
N/A	Flare Traversable LT?	N/A	N/A	Flare Traversable RT?	N/A
N/A	Landing Length (in)	N/A	N/A	DWS Provided?	N/A
N/A	Landing Width (in)	N/A	N/A	DWS Contrast?	N/A
N/A	Landing Slope (%)	N/A	N/A	DWS Length (in)	N/A
N/A	Landing X Slope (%)	N/A	N/A	DWS Full Width?	N/A
N/A	Landing Curb? (Y/N)	N/A	N/A	DWS Offset (in)	N/A
N/A	Shared Landing?	N/A			
N/A	Gutter Ponding?	N/A	N/A	Gutter Slope (%)	N/A
N/A	Gutter Lip Ht (in)	N/A	N/A	Gutter X Slope (%)	N/A
N/A	Painted X Walk1?	No	N/A	Painted X Walk2?	No
	X Walk 1 Direction	To NW		X Walk 2 Direction	To SW
N/A	X Walk 1 Width (in)	N/A	N/A	X Walk 2 Width (in)	N/A
	X Walk 1 Slope (%)	4.3		X Walk 2 Slope (%)	2.9
	X Walk 1 X Slope (%)	2.4		X Walk 2 X Slope (%)	3.7

N/A	Ramp inside XWalk1?	N/A	N/A	Ramp inside XWalk2?	N/A
	Road Slope (%)	1.2	N/A	Clear Space?	N/A
	Road X Slope (%)	6.2	N/A	Clear Space to XWalk (in)	N/A
N/A	Any Obstructions?	N/A	N/A	Storm Grate/Utility Hazard?	N/A
	Obstruction Type			Storm Grate/Utility Type	
		N/A			N/A
			Yes	Surface Condition? (G/P)	Good

**Remove & Replace Curb Ramp With Two New Directional Ramps or Equivalent.**

Total Cost: \$ 3200.00
