Access Compliance Report

Public Rights-of-Way

(Curb Ramps)

Intersection ID: 48416	Main Street: YORK_CROSSING_DR	Cross Street: S_TRYON_ST	Location: SE
ADA ID: 8C7F9D0F0E6F	Ramp Type: Perp	Initial Pass/Fail: Fail	Overall Compliance: No
Codes/Mitigation Info/Possible Solution		Field Measurements/Component Compliance	
Severity Score: 46.25

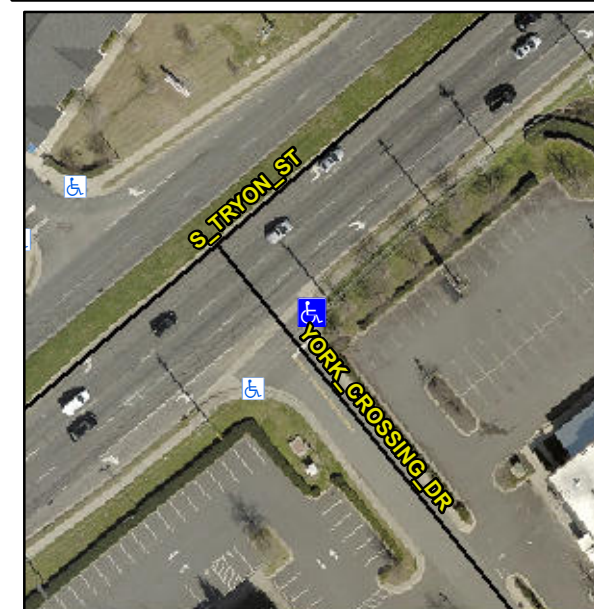
Compliance	Description	Data	Compliance	Description	Data
N/A	Ramp Length (in)	49.0	No	Ramp Slope (%)	12.9
No	Ramp Width (in)	46.0	No	Ramp XSlope (%)	5.8
N/A	Flare Type LT	N/A	N/A	Flare Type RT	N/A
N/A	Flare Slope LT (%)	N/A	N/A	Flare Slope RT (%)	N/A
N/A	Flare Traversable LT?	N/A	N/A	Flare Traversable RT?	N/A
N/A	Landing Length (in)	N/A	N/A	DWS Provided?	N/A
N/A	Landing Width (in)	N/A	N/A	DWS Contrast?	N/A
N/A	Landing Slope (%)	N/A	N/A	DWS Length (in)	N/A
N/A	Landing X Slope (%)	N/A	N/A	DWS Full Width?	N/A
N/A	Landing Curb? (Y/N)	N/A	N/A	DWS Offset (in)	N/A
N/A	Shared Landing?	N/A			
N/A	Gutter Ponding?	N/A	N/A	Gutter Slope (%)	N/A
N/A	Gutter Lip Ht (in)	N/A	N/A	Gutter X Slope (%)	N/A
N/A	Painted X Walk1?	No	N/A	Painted X Walk2?	N/A
	X Walk 1 Direction	To SW		X Walk 2 Direction	N/A
N/A	X Walk 1 Width (in)	N/A	N/A	X Walk 2 Width (in)	N/A
	X Walk 1 Slope (%)	0.4		X Walk 2 Slope (%)	N/A
	X Walk 1 X Slope (%)	6.0		X Walk 2 X Slope (%)	N/A

N/A	Ramp inside XWalk1?	N/A	N/A	Ramp inside XWalk2?	N/A
	Road Slope (%)	N/A	N/A	Clear Space?	N/A
	Road X Slope (%)	N/A	N/A	Clear Space to XWalk (in)	N/A
N/A	Any Obstructions?	N/A	N/A	Storm Grate/Utility Hazard?	N/A
	Obstruction Type			Storm Grate/Utility Type	
		N/A			N/A
			Yes	Surface Condition? (G/P)	Good

Possible Solutions:

Remove & Replace Entire Ramp.

R304.5.1, R304.2.2, R304.5.3
