# Access Compliance Report

## Public Rights-of-Way

### (Curb Ramps)

Intersection ID: 14779	Main Street: ALBEMARLE_RD	Cross Street: MALLARD_DR	Location: NW
ADA ID: 8C8C03444AC7	Ramp Type: PerpDiag	Initial Pass/Fail: Fail	Overall Compliance: No
			Severity Score: 13.75

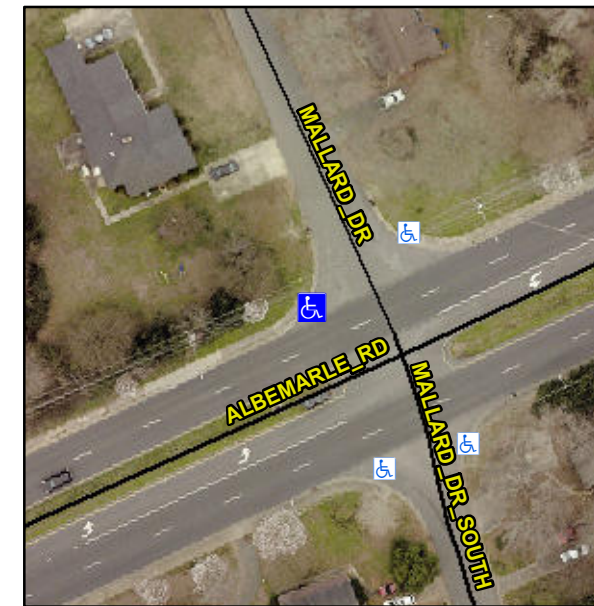
Compliance	Description	Data	Compliance	Description	Data
N/A	Ramp Length (in)	59.0	No	Ramp Slope (%)	9.2
Yes	Ramp Width (in)	48.0	No	Ramp XSlope (%)	3.0
N/A	Flare Type LT	N/A	N/A	Flare Type RT	N/A
N/A	Flare Slope LT (%)	N/A	N/A	Flare Slope RT (%)	N/A
N/A	Flare Traversable LT?	N/A	N/A	Flare Traversable RT?	N/A
N/A	Landing Length (in)	N/A	N/A	DWS Provided?	N/A
N/A	Landing Width (in)	N/A	N/A	DWS Contrast?	N/A
N/A	Landing Slope (%)	N/A	N/A	DWS Length (in)	N/A
N/A	Landing X Slope (%)	N/A	N/A	DWS Full Width?	N/A
N/A	Landing Curb? (Y/N)	N/A	N/A	DWS Offset (in)	N/A
N/A	Shared Landing?	N/A			
N/A	Gutter Ponding?	N/A	N/A	Gutter Slope (%)	N/A
N/A	Gutter Lip Ht (in)	N/A	N/A	Gutter X Slope (%)	N/A
N/A	Painted X Walk1?	No	N/A	Painted X Walk2?	No
	X Walk 1 Direction	To S		X Walk 2 Direction	To E
N/A	X Walk 1 Width (in)	N/A	N/A	X Walk 2 Width (in)	N/A
	X Walk 1 Slope (%)	2.9		X Walk 2 Slope (%)	0.3
	X Walk 1 X Slope (%)	1.0		X Walk 2 X Slope (%)	3.1

N/A	Ramp inside XWalk1?	N/A	N/A	Ramp inside XWalk2?	N/A
	Road Slope (%)	2.8	N/A	Clear Space?	N/A
	Road X Slope (%)	2.7	N/A	Clear Space to XWalk (in)	N/A
N/A	Any Obstructions?	N/A	N/A	Storm Grate/Utility Hazard?	N/A
	Obstruction Type			Storm Grate/Utility Type	
		N/A			N/A
			Yes	Surface Condition? (G/P)	Good

**Remove & Replace Curb Ramp With Two New Directional Ramps or Equivalent.**

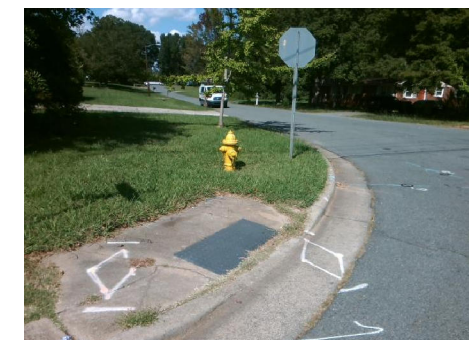
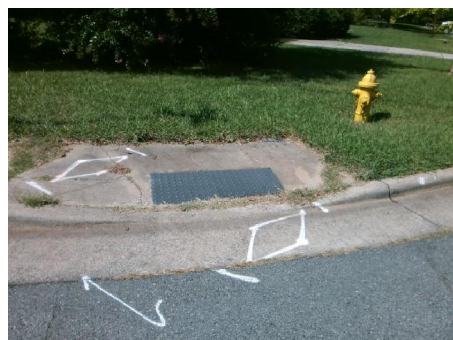
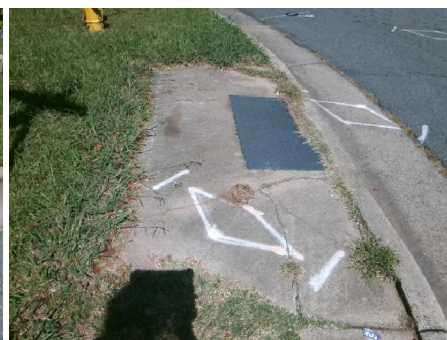
**Not Found, R304.2.2, R304.5.3**
