Access Compliance Report

Public Rights-of-Way

(Curb Ramps)

Intersection ID: 16497	Main Street: HAMPTON_AV	Cross Street: PORTLAND_AV	Location: SW
ADA ID: 8C904E0CF2F3	Ramp Type: Combination2Diag	Initial Pass/Fail: Fail	Overall Compliance: No
		Severity Score: 0

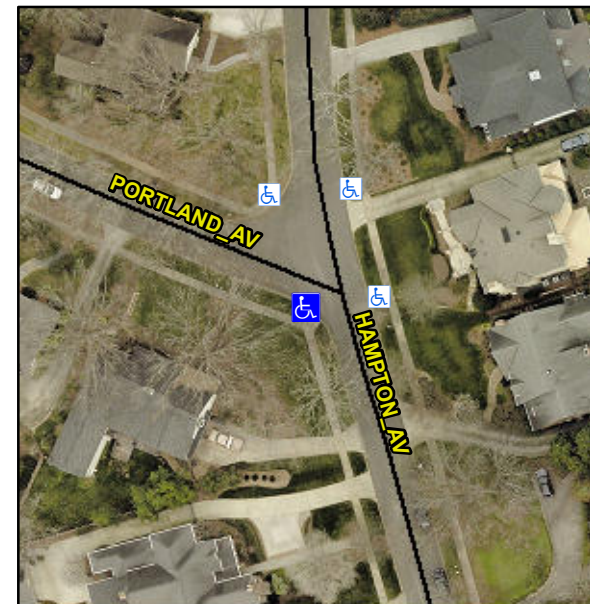
R304.5.1, R304.5.1, R304.5.3, R304.3.2

Compliance	Description	Data	Compliance	Description	Data
N/A	Ramp Length LT (in)	N/A	N/A	Ramp Length RT (in)	123.0
N/A	Ramp Width LT (in)	N/A	No	Ramp Width RT (in)	45.5
N/A	Ramp Slope LT (%)	N/A	No	Ramp Slope RT (%)	9.2
N/A	Ramp XSlope LT (%)	N/A	Yes	Ramp XSlope RT (%)	1.0
N/A	Ramp Length (in)	76.0	Yes	Ramp Slope (%)	7.7
No	Ramp Width (in)	46.5	No	Ramp XSlope (%)	6.7
N/A	Flare Type LT	N/A	N/A	Flare Type RT	N/A
N/A	Flare Slope LT (%)	N/A	N/A	Flare Slope RT (%)	N/A
N/A	Flare Traversable LT?	N/A	N/A	Flare Traversable RT?	N/A
N/A	Landing Length (in)	N/A	N/A	DWS Provided?	N/A
N/A	Landing Width (in)	N/A	N/A	DWS Contrast?	N/A
N/A	Landing Slope (%)	N/A	N/A	DWS Length (in)	N/A
N/A	Landing X Slope (%)	N/A	N/A	DWS Full Width?	N/A
N/A	Landing Curb? (Y/N)	N/A	N/A	DWS Offset (in)	N/A
N/A	Shared Landing?	N/A			
N/A	Gutter Ponding?	N/A	N/A	Gutter Slope (%)	N/A
N/A	Gutter Lip Ht (in)	N/A	N/A	Gutter X Slope (%)	N/A
N/A	Painted X Walk1?	No	N/A	Painted X Walk2?	No

Remove & Replace Curb Ramp With Two New Directional Ramps or Equivalent.

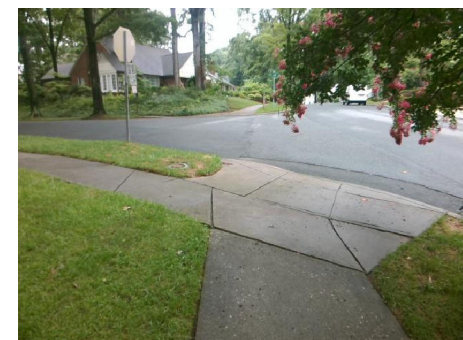
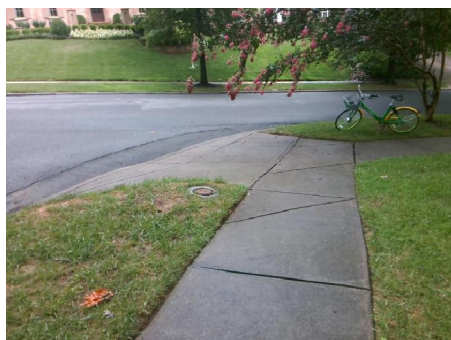
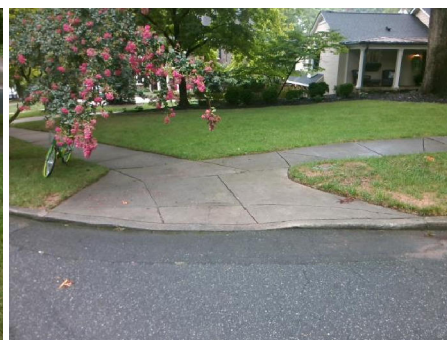
X Walk 1 Direction	To E		X Walk 2 Direction	To N
	X Walk 1 Width (in)	N/A		X Walk 2 Width (in)	N/A
	X Walk 1 Slope (%)	4.5		X Walk 2 Slope (%)	9.0
	X Walk 1 X Slope (%)	9.7		X Walk 2 X Slope (%)	0.7
N/A	Ramp inside XWalk1?	N/A	N/A	Ramp inside XWalk2?	N/A
	Road Slope (%)	4.6		Clear Space?	N/A
	Road X Slope (%)	9.7	N/A	Clear Space to XWalk (in)	N/A
			N/A	Any Obstruction?	N/A
				Obstruction Type	N/A
			N/A	Storm Grate/Utility Hazard?	N/A
				Storm Grate/Utility Type	N/A
			Yes	Surface Condition? (G/P)	Good
				Curb Slope (%)	N/A
