# Access Compliance Report

## Public Rights-of-Way

### (Curb Ramps)

Intersection ID: 44913	Main Street: SPRINGHAVEN_DR	Cross Street: OAK_DR	Location:	NE
ADA ID: 8CA2632EC20B	Ramp Type: Perp	Initial Pass/Fail: Fail	Overall Compliance: No	Severity Score: 60
Codes/Mitigation Info/Possible Solution		Field Measurements/Component Compliance

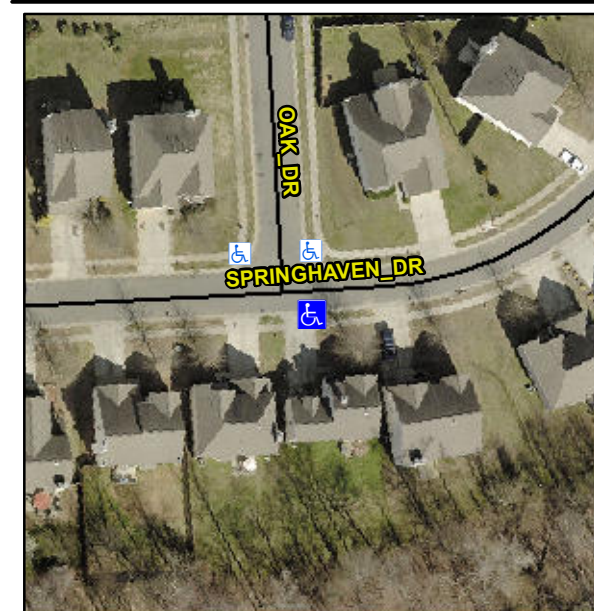
**Not Found, R304.5.1, R304.2.2**

Compliance	Description	Data	Compliance	Description	Data
N/A	Ramp Length (in)	47.0	No	Ramp Slope (%)	16.1
No	Ramp Width (in)	31.0	Yes	Ramp XSlope (%)	0.9
N/A	Flare Type LT	N/A	N/A	Flare Type RT	N/A
N/A	Flare Slope LT (%)	N/A	N/A	Flare Slope RT (%)	N/A
N/A	Flare Traversable LT?	N/A	N/A	Flare Traversable RT?	N/A
N/A	Landing Length (in)	N/A	N/A	DWS Provided?	N/A
N/A	Landing Width (in)	N/A	N/A	DWS Contrast?	N/A
N/A	Landing Slope (%)	N/A	N/A	DWS Length (in)	N/A
N/A	Landing X Slope (%)	N/A	N/A	DWS Full Width?	N/A
N/A	Landing Curb? (Y/N)	N/A	N/A	DWS Offset (in)	N/A
N/A	Shared Landing?	N/A			
N/A	Gutter Ponding?	N/A	N/A	Gutter Slope (%)	N/A
N/A	Gutter Lip Ht (in)	N/A	N/A	Gutter X Slope (%)	N/A
N/A	Painted X Walk1?	No	N/A	Painted X Walk2?	N/A
	X Walk 1 Direction	To N		X Walk 2 Direction	N/A
N/A	X Walk 1 Width (in)	N/A	N/A	X Walk 2 Width (in)	N/A
	X Walk 1 Slope (%)	2.5		X Walk 2 Slope (%)	N/A
	X Walk 1 X Slope (%)	1.6		X Walk 2 X Slope (%)	N/A

N/A	Ramp inside XWalk1?	N/A	N/A	Ramp inside XWalk2?	N/A
	Road Slope (%)	N/A	N/A	Clear Space?	N/A
	Road X Slope (%)	N/A	N/A	Clear Space to XWalk (in)	N/A
N/A	Any Obstructions?	N/A	N/A	Storm Grate/Utility Hazard?	N/A
	Obstruction Type			Storm Grate/Utility Type	
		N/A			N/A
			Yes	Surface Condition? (G/P)	Good

**Remove & Replace Entire Ramp.**
