# Access Compliance Report

## Public Rights-of-Way

### (Curb Ramps)

Intersection ID: 45515	Main Street: COTTON_PRESS_RD	Cross Street: HEDGEROW_PARK_RD	Location: W
ADA ID: 8CA7440DA3CF	Ramp Type: PerpDiag	Initial Pass/Fail: Fail	Overall Compliance: No
Severity Score: 47.5			
Codes/Mitigation Info/Possible Solution		Field Measurements/Component Compliance

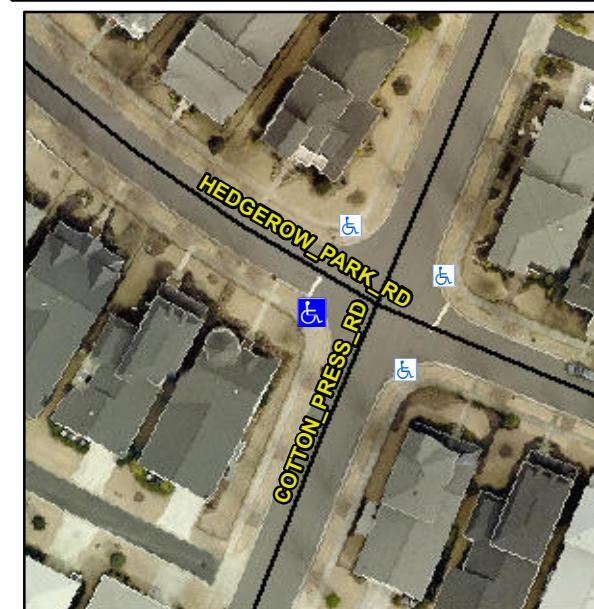
**Not Found, R304.5.1, R304.2.2**

Compliance	Description	Data	Compliance	Description	Data
N/A	Ramp Length (in)	72.0	No	Ramp Slope (%)	10.2
No	Ramp Width (in)	28.0	Yes	Ramp XSlope (%)	0.9
N/A	Flare Type LT	N/A	N/A	Flare Type RT	N/A
N/A	Flare Slope LT (%)	N/A	N/A	Flare Slope RT (%)	N/A
N/A	Flare Traversable LT?	N/A	N/A	Flare Traversable RT?	N/A
N/A	Landing Length (in)	N/A	N/A	DWS Provided?	N/A
N/A	Landing Width (in)	N/A	N/A	DWS Contrast?	N/A
N/A	Landing Slope (%)	N/A	N/A	DWS Length (in)	N/A
N/A	Landing X Slope (%)	N/A	N/A	DWS Full Width?	N/A
N/A	Landing Curb? (Y/N)	N/A	N/A	DWS Offset (in)	N/A
N/A	Shared Landing?	N/A			
N/A	Gutter Ponding?	N/A	N/A	Gutter Slope (%)	N/A
N/A	Gutter Lip Ht (in)	N/A	N/A	Gutter X Slope (%)	N/A
N/A	Painted X Walk1?	No	N/A	Painted X Walk2?	No
	X Walk 1 Direction	To SE		X Walk 2 Direction	To NE
N/A	X Walk 1 Width (in)	N/A	N/A	X Walk 2 Width (in)	N/A
	X Walk 1 Slope (%)	0.6		X Walk 2 Slope (%)	3.5
	X Walk 1 X Slope (%)	1.8		X Walk 2 X Slope (%)	0.3

N/A	Ramp inside XWalk1?	N/A	N/A	Ramp inside XWalk2?	N/A
	Road Slope (%)	2.0	N/A	Clear Space?	N/A
	Road X Slope (%)	3.8	N/A	Clear Space to XWalk (in)	N/A
N/A	Any Obstructions?	N/A	N/A	Storm Grate/Utility Hazard?	N/A
	Obstruction Type			Storm Grate/Utility Type	
		N/A			N/A
			Yes	Surface Condition? (G/P)	Good

**Remove & Replace Curb Ramp With Two New Directional Ramps or Equivalent.**
