## Access Compliance Report Public Rights-of-Way (Curb Ramps)

Intersection ID: 25995 Main Street: WEDDINGTON\_RD Cross Street: PLANTATION\_CENTER\_DR Location: NW

ADA ID: 8CB1B6CF45C3 Ramp Type: Para Initial Pass/Fail: Fail Overall Compliance: No Severity Score: 13.75

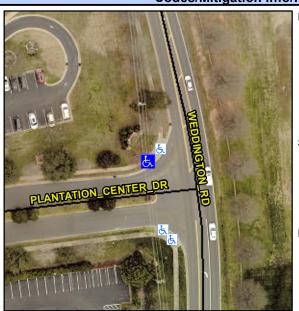
Compliance Description [		Data	Comp	Compliance Description	
N/A	Ramp Length LT (in)	78.0	N/A	Ramp Length RT (in)	67.0
Yes	Ramp Width LT (in)	96.0	Yes	Ramp Width RT (in)	96.0
Yes	Ramp Slope LT (%)	6.3	No	Ramp Slope RT (%)	9.7
No	Ramp XSlope LT (%)	2.2	No	Ramp XSlope RT (%)	4.0
N/A	Landing Length (in)	N/A	N/A	DWS Provided?	N/A
N/A	Landing Width (in)	N/A	N/A	DWS Contrast?	N/A
N/A	Landing Slope (%)	N/A	N/A	DWS Length (in)	N/A
N/A	Landing X Slope (%)	N/A	N/A	DWS Full Width?	N/A
N/A	Landing Curb? (Y/N)	N/A	N/A	DWS Offset (in)	N/A
N/A	Shared Landing?	N/A			
N/A	Gutter Ponding?	N/A	N/A	Gutter Slope (%)	N/A
N/A	Gutter Lip Ht (in)	N/A	N/A	Gutter X Slope (%)	N/A
N/A	Painted X Walk1?	No	N/A	Painted X Walk2?	N/A
	X Walk 1 Direction	To SE		X Walk 2 Direction	N/A
N/A	X Walk 1 Width (in)	N/A	N/A	X Walk 2 Width (in)	N/A
	X Walk 1 Slope (%)	0.2		X Walk 2 Slope (%)	N/A
	X Walk 1 X Slope (%)	0.8		X Walk 2 X Slope (%)	N/A
N/A	Ramp inside XWalk1?	N/A	N/A	Ramp inside XWalk2?	N/A

Road Slope (%)	N/A	N/A	Clear Space?	N/A
	Road X Slope (%)	N/A	N/A	Clear Space to XWalk (in)	N/A
N/A	Any Obstructions?	N/A	N/A	Storm Grate/Utility Hazard?	N/A
	Obstruction Type			Storm Grate/Utility Type	
		N/A			N/A
			Yes	Surface Condition? (G/P)	Good
			N/A	Curb Slope (%)	10.0

Possible Solution			
Possible Solutions:	9		
Remove & Replace Entire Ramp.			
·	١		
	١		
	N		
	N		
	N		
Surveyor Notes:	N		
N/A	N		
	N		
	N		
	N		
PROW/ADA:	N		
R304.5.3, R304.3.2	N		
	N

Total Cost: \$ 1600.00
