# Access Compliance Report

## Public Rights-of-Way

### (Curb Ramps)

Intersection ID: 10011741	Main Street: N_SHARON_AMITY_RD	Cross Street: N/A	Location: SE
ADA ID: 8CD09AC9781E	Ramp Type: PerpDiag	Initial Pass/Fail: Fail	Overall Compliance: No
Codes/Mitigation Info/Possible Solution		Field Measurements/Component Compliance

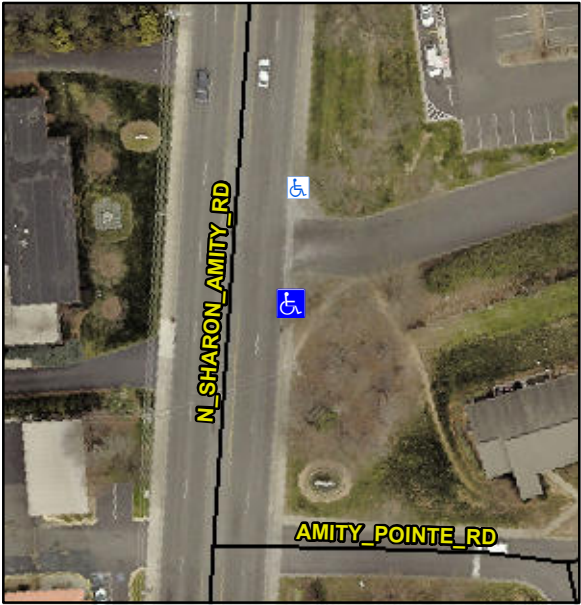
Compliance	Description	Data	Compliance	Description	Data
N/A	Ramp Length (in)	60.0	No	Ramp Slope (%)	15.4
No	Ramp Width (in)	45.0	No	Ramp XSlope (%)	3.0
N/A	Flare Type LT	N/A	N/A	Flare Type RT	N/A
N/A	Flare Slope LT (%)	N/A	N/A	Flare Slope RT (%)	N/A
N/A	Flare Traversable LT?	N/A	N/A	Flare Traversable RT?	N/A
N/A	Landing Length (in)	N/A	N/A	DWS Provided?	N/A
N/A	Landing Width (in)	N/A	N/A	DWS Contrast?	N/A
N/A	Landing Slope (%)	N/A	N/A	DWS Length (in)	N/A
N/A	Landing X Slope (%)	N/A	N/A	DWS Full Width?	N/A
N/A	Landing Curb? (Y/N)	N/A	N/A	DWS Offset (in)	N/A
N/A	Shared Landing?	N/A			
N/A	Gutter Ponding?	N/A	N/A	Gutter Slope (%)	N/A
N/A	Gutter Lip Ht (in)	N/A	N/A	Gutter X Slope (%)	N/A
N/A	Painted X Walk1?	No	N/A	Painted X Walk2?	No
	X Walk 1 Direction	To N		X Walk 2 Direction	To W
N/A	X Walk 1 Width (in)	N/A	N/A	X Walk 2 Width (in)	N/A
	X Walk 1 Slope (%)	3.2		X Walk 2 Slope (%)	1.9
	X Walk 1 X Slope (%)	2.0		X Walk 2 X Slope (%)	0.9

N/A	Ramp inside XWalk1?	N/A	N/A	Ramp inside XWalk2?	N/A
	Road Slope (%)	2.7	N/A	Clear Space?	N/A
	Road X Slope (%)	0.1	N/A	Clear Space to XWalk (in)	N/A
N/A	Any Obstructions?	N/A	N/A	Storm Grate/Utility Hazard?	N/A
	Obstruction Type			Storm Grate/Utility Type	
		N/A			N/A
		No		Surface Condition? (G/P)	Poor

Possible Solutions:		<b>Remove &amp; Replace Curb Ramp With Two New Directional Ramps or Equivalent.</b>
	Surveyor Notes:		<b>N/A</b>
<p>Street 1 Name</p> <p>Stop Condition-Street 2</p> <p>Street 2 Name</p> <p>Stop Condition-Street 1</p>	ENTRANCE		<b>None</b>
	N SHARON AMITY RD		<b>None</b>
PROW/ADA:		<b>Not Found, R304.5.1, R304.2.2, R304.5.3, R302.7</b>	
Total Cost:		\$ 3200.00
