# Access Compliance Report

## Public Rights-of-Way

| Intersection ID: 19928 | Main Street: BARCLAY_DOWNS_DR | Cross Street: CARNEGIE_BV | Location: NE |
| ADA ID: 8CF29CE6B2B1 | Ramp Type: PerpDiag | Initial Pass/Fail: Fail | Overall Compliance: No |

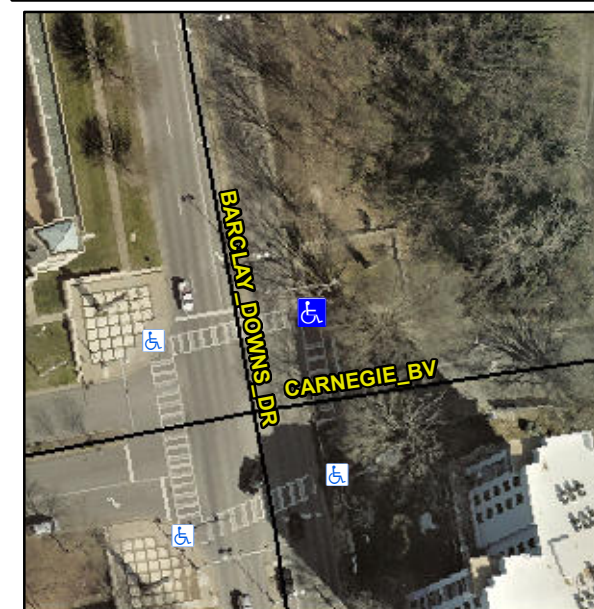
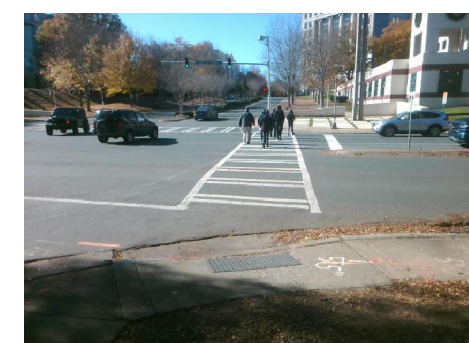
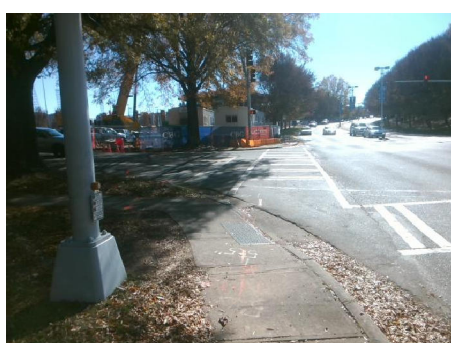
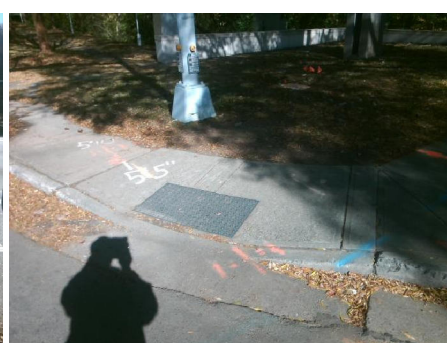
| Severity Score: 50 | | | |

**Not Found, R304.2.2, R304.5.3**

| Compliance | Description | Data | Compliance | Description | Data |
|---|---|---|---|---|---|
| N/A | Ramp Length (in) | 60.0 | No | Ramp Slope (%) | 14.4 |
| Yes | Ramp Width (in) | 48.0 | No | Ramp XSlope (%) | 7.0 |

**Remove & Replace Curb Ramp With Two New Directional Ramps or Equivalent.**

Total Cost: \$ 3200.00
