Intersection ID: 48283	Main Street: MEADOWMONT_VIEW_DR	Cross Street: MEADOWMONT_VIEW_DR	Location:	SE
ADA ID: 8CF314DC282A	Ramp Type: PerpDiag	Initial Pass/Fail: Fail	Overall Compliance: No	Severity Score: 8.75

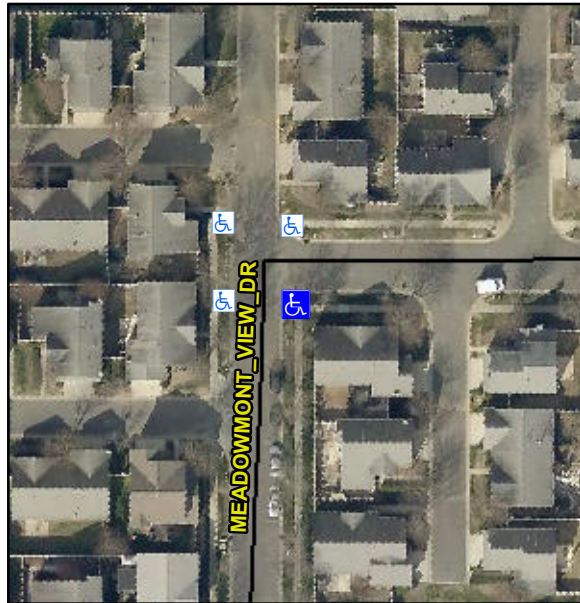
**Not Found, R304.5.1**

Compliance	Description	Data	Compliance	Description	Data
N/A	Ramp Length (in)	52.0	Yes	Ramp Slope (%)	8.3
No	Ramp Width (in)	41.0	Yes	Ramp XSlope (%)	1.0
N/A	Flare Type LT	N/A	N/A	Flare Type RT	N/A
N/A	Flare Slope LT (%)	N/A	N/A	Flare Slope RT (%)	N/A
N/A	Flare Traversable LT?	N/A	N/A	Flare Traversable RT?	N/A
N/A	Landing Length (in)	N/A	N/A	DWS Provided?	N/A
N/A	Landing Width (in)	N/A	N/A	DWS Contrast?	N/A
N/A	Landing Slope (%)	N/A	N/A	DWS Length (in)	N/A
N/A	Landing X Slope (%)	N/A	N/A	DWS Full Width?	N/A
N/A	Landing Curb? (Y/N)	N/A	N/A	DWS Offset (in)	N/A
N/A	Shared Landing?	N/A			
N/A	Gutter Ponding?	N/A	N/A	Gutter Slope (%)	N/A
N/A	Gutter Lip Ht (in)	N/A	N/A	Gutter X Slope (%)	N/A
N/A	Painted X Walk1?	No	N/A	Painted X Walk2?	No
	X Walk 1 Direction	To N		X Walk 2 Direction	To W
N/A	X Walk 1 Width (in)	N/A	N/A	X Walk 2 Width (in)	N/A
	X Walk 1 Slope (%)	0.6		X Walk 2 Slope (%)	2.1
	X Walk 1 X Slope (%)	0.4		X Walk 2 X Slope (%)	1.2

N/A	Ramp inside XWalk1?	N/A	N/A	Ramp inside XWalk2?	N/A
	Road Slope (%)	0.8	N/A	Clear Space?	N/A
	Road X Slope (%)	1.3	N/A	Clear Space to XWalk (in)	N/A
N/A	Any Obstructions?	N/A	N/A	Storm Grate/Utility Hazard?	N/A
	Obstruction Type			Storm Grate/Utility Type	
		N/A			N/A
			Yes	Surface Condition? (G/P)	Good

**Remove & Replace Curb Ramp With Two New Directional Ramps or Equivalent.**
