Access Compliance Report

Public Rights-of-Way

(Curb Ramps)

Intersection ID: 49382	Main Street: SOUTH_DEVON_ST	Cross Street: ROCKY_RIVER_RD	Location: SW
ADA ID: 8CF6C648CF6B	Ramp Type: Perp	Initial Pass/Fail: Fail	Overall Compliance: No
		Severity Score: 1.25

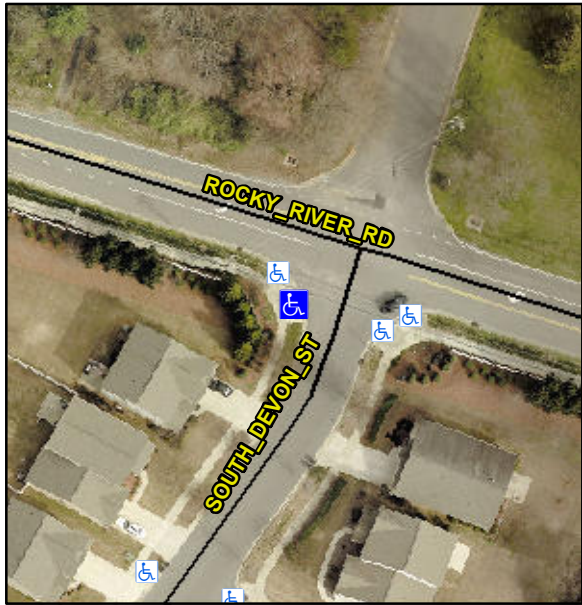
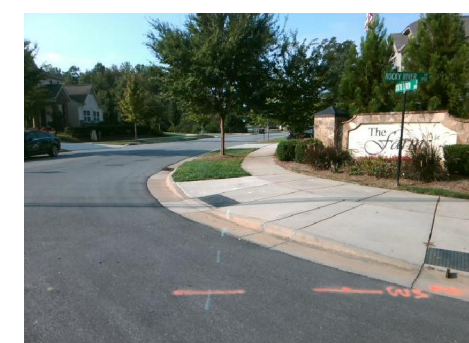
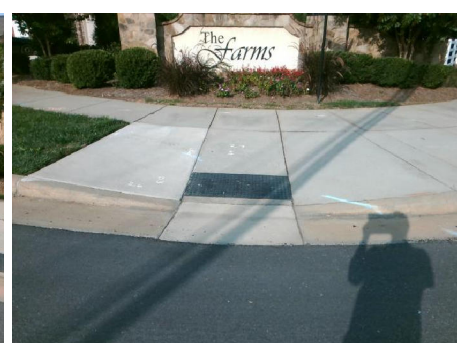
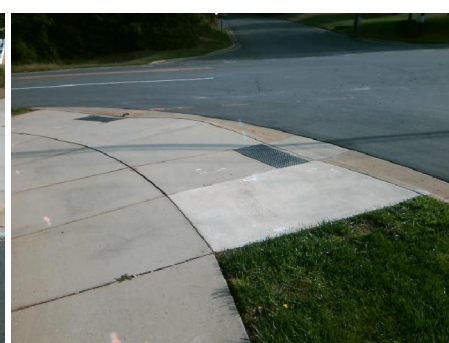
Possible Solutions:		Compliance	Description	Data	Compliance	Description	Data
	Remove & Replace Entire Ramp.		N/A	Ramp Length (in)	97.0	Yes	Ramp Slope (%)	6.9
			Yes	Ramp Width (in)	48.0	No	Ramp XSlope (%)	2.7
			N/A	Flare Type LT	N/A	N/A	Flare Type RT	N/A
			N/A	Flare Slope LT (%)	N/A	N/A	Flare Slope RT (%)	N/A
			N/A	Flare Traversable LT?	N/A	N/A	Flare Traversable RT?	N/A
			N/A	Landing Length (in)	N/A	N/A	DWS Provided?	N/A
			N/A	Landing Width (in)	N/A	N/A	DWS Contrast?	N/A
			N/A	Landing Slope (%)	N/A	N/A	DWS Length (in)	N/A
			N/A	Landing X Slope (%)	N/A	N/A	DWS Full Width?	N/A
Surveyor Notes:		N/A	N/A	Landing Curb? (Y/N)	N/A	N/A	DWS Offset (in)	N/A
PROW/ADA:		Not Found, R304.5.3	N/A	Shared Landing?	N/A			
			N/A	Gutter Ponding?	N/A	N/A	Gutter Slope (%)	N/A
			N/A	Gutter Lip Ht (in)	N/A	N/A	Gutter X Slope (%)	N/A

N/A	Painted X Walk1?	No	N/A	Painted X Walk2?	N/A
				X Walk 1 Direction	To SE		X Walk 2 Direction	N/A
			N/A	X Walk 1 Width (in)	N/A	N/A	X Walk 2 Width (in)	N/A
				X Walk 1 Slope (%)	0.3		X Walk 2 Slope (%)	N/A
				X Walk 1 X Slope (%)	2.6		X Walk 2 X Slope (%)	N/A
			N/A	Ramp inside XWalk1?	N/A	N/A	Ramp inside XWalk2?	N/A
				Road Slope (%)	N/A	N/A	Clear Space?	N/A
				Road X Slope (%)	N/A	N/A	Clear Space to XWalk (in)	N/A
			N/A	Any Obstructions?	N/A	N/A	Storm Grate/Utility Hazard?	N/A
				Obstruction Type			Storm Grate/Utility Type	
					N/A			N/A
						Yes	Surface Condition? (G/P)	Good
Total Cost:		\$ 1850.00						
Street 1 Name		SOUTH DEVON ST						
Stop Condition-Street 2		StopSign						
Street 2 Name		N/A						
Stop Condition-Street 1		N/A
