Access Compliance Report

Public Rights-of-Way

(Curb Ramps)

Intersection ID: 2782	Main Street: AVONHURST_LN	Cross Street: MCTAGGART_LN	Location: SW
ADA ID: 8CFAA9F62A08	Ramp Type: PerpDiag	Initial Pass/Fail: Fail	Overall Compliance: No
Severity Score: 25			
Codes/Mitigation Info/Possible Solution		Field Measurements/Component Compliance

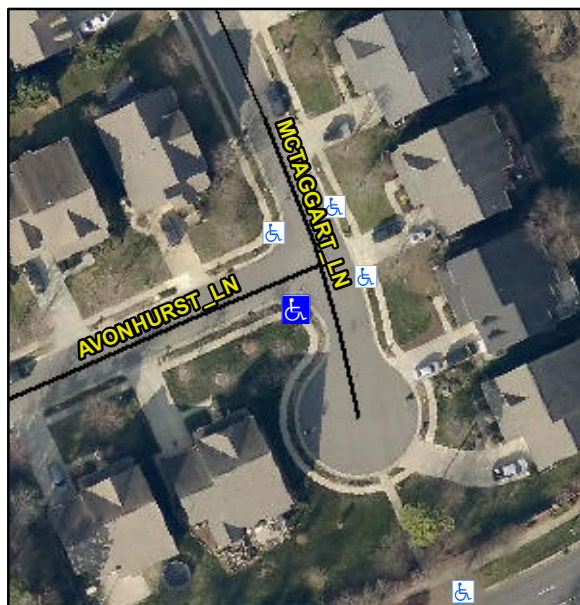
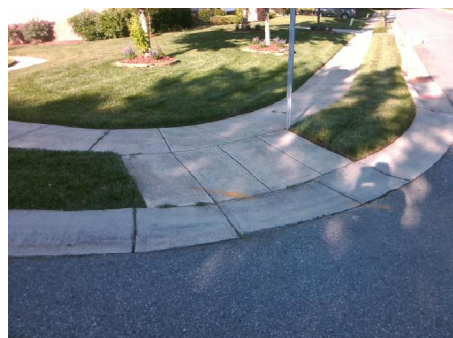
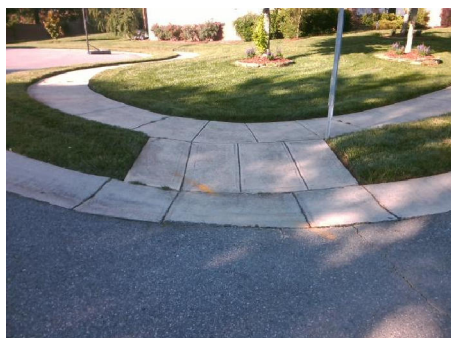
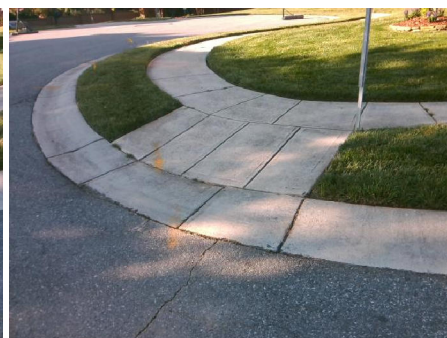
Compliance	Description	Data	Compliance	Description	Data
N/A	Ramp Length (in)	50.0	No	Ramp Slope (%)	14.1
Yes	Ramp Width (in)	50.0	Yes	Ramp XSlope (%)	1.3
N/A	Flare Type LT	N/A	N/A	Flare Type RT	N/A
N/A	Flare Slope LT (%)	N/A	N/A	Flare Slope RT (%)	N/A
N/A	Flare Traversable LT?	N/A	N/A	Flare Traversable RT?	N/A
N/A	Landing Length (in)	N/A	N/A	DWS Provided?	N/A
N/A	Landing Width (in)	N/A	N/A	DWS Contrast?	N/A
N/A	Landing Slope (%)	N/A	N/A	DWS Length (in)	N/A
N/A	Landing X Slope (%)	N/A	N/A	DWS Full Width?	N/A
N/A	Landing Curb? (Y/N)	N/A	N/A	DWS Offset (in)	N/A
N/A	Shared Landing?	N/A			
N/A	Gutter Ponding?	N/A	N/A	Gutter Slope (%)	N/A
N/A	Gutter Lip Ht (in)	N/A	N/A	Gutter X Slope (%)	N/A
N/A	Painted X Walk1?	No	N/A	Painted X Walk2?	No
	X Walk 1 Direction	To E		X Walk 2 Direction	To N
N/A	X Walk 1 Width (in)	N/A	N/A	X Walk 2 Width (in)	N/A
	X Walk 1 Slope (%)	1.4		X Walk 2 Slope (%)	3.4
	X Walk 1 X Slope (%)	7.1		X Walk 2 X Slope (%)	1.1

N/A	Ramp inside XWalk1?	N/A	N/A	Ramp inside XWalk2?	N/A
	Road Slope (%)	2.6	N/A	Clear Space?	N/A
	Road X Slope (%)	1.6	N/A	Clear Space to XWalk (in)	N/A
N/A	Any Obstructions?	N/A	N/A	Storm Grate/Utility Hazard?	N/A
	Obstruction Type			Storm Grate/Utility Type	
		N/A			N/A
		Yes		Surface Condition? (G/P)	Good

Possible Solutions:

Remove & Replace Curb Ramp With Two New Directional Ramps or Equivalent.

Not Found, R304.2.2
