## **Access Compliance Report Public Rights-of-Way** (Curb Ramps)

Intersection ID: 16557 Main Street: ALLISTER DR **Cross Street: WALNUT WOOD DR** Location: W ADA ID: 8D0E07F4E337 Ramp Type: PerpDiag Initial Pass/Fail: Fail **Overall Compliance: No Severity Score:** 50

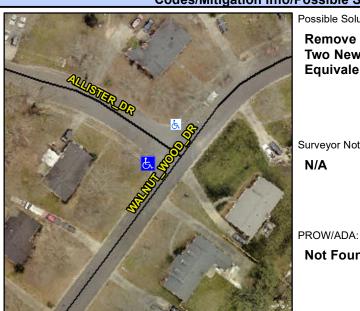
Not Found, R304.2.2, R304.5.3

Comp	liance Description	Data	Comp	liance	Description	Data
N/A	Ramp Length (in)	63.0	No	Ramp	Slope (%)	12.3
Yes	Ramp Width (in)	48.0	No	Ramp	XSlope (%)	9.1
N/A	Flare Type LT	N/A	N/A	Flare T	ype RT	N/A
N/A	Flare Slope LT (%)	N/A	N/A	Flare S	Slope RT (%)	N/A
N/A	Flare Traversable LT?	N/A	N/A	Flare T	raversable RT?	N/A
N/A	Landing Length (in)	N/A	N/A	DWS F	Provided?	N/A
N/A	Landing Width (in)	N/A	N/A	DWS (	Contrast?	N/A
N/A	Landing Slope (%)	N/A	N/A	DWS L	ength (in)	N/A
N/A	Landing X Slope (%)	N/A	N/A	DWS F	Full Width?	N/A
N/A	Landing Curb? (Y/N)	N/A	N/A	DWS (	Offset (in)	N/A
N/A	Shared Landing?	N/A				
N/A	Gutter Ponding?	N/A	N/A	Gutter	Slope (%)	N/A
N/A	Gutter Lip Ht (in)	N/A	N/A	Gutter	X Slope (%)	N/A
N/A	Painted X Walk1?	No	N/A	Painte	d X Walk2?	No
	X Walk 1 Direction	To NE		X Walk	2 Direction	To SE
N/A	X Walk 1 Width (in)	N/A	N/A	X Walk	2 Width (in)	N/A
	X Walk 1 Slope (%)	0.8		X Walk	( 2 Slope (%)	7.3
	X Walk 1 X Slope (%)	5.4		X Walk	2 X Slope (%)	2.1

N/A	Ramp inside XWalk1?	N/A	N/A	Ramp	inside XWalk2?	N/A
	Road Slope (%)	5.5	N/A	Clear S	Space?	N/A
	Road X Slope (%)	4.0	N/A	Clear S	Space to XWalk (in)	N/A
N/A	Any Obstructions?	N/A	N/A	Storm	Grate/Utility Hazard?	N/A
	Obstruction Type		l	Storm	Grate/Utility Type	
		N/A				N/A
			Yes	Surfac	e Condition? (G/P)	Good

Possible Solutions: Remove & Replace Curb Ramp With **Two New Directional Ramps or** Equivalent. Surveyor Notes: N/A

Total Cost: 3200.00
