Access Compliance Report Public Rights-of-Way (Curb Ramps)

Intersection ID: 50636 Main Street: BLUE GROVE RD Cross Street: RED_WATER_RD Location: SE ADA ID: 8D110931F88A Ramp Type: Perp Initial Pass/Fail: Fail **Overall Compliance: No Severity Score:** 50

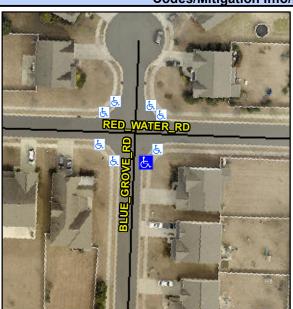
| Field Measurements/Component Compliance | | | | | | | | |
|---|---|---|---|---|---|---|--|--|
| N/A | Ramp Length (in) | 48.0 | No | Ramp | Slope (%) | 12.4 | | |
| Yes | Ramp Width (in) | 48.0 | No | Ramp | XSlope (%) | 7.1 | | |

Possible Solutions: Remove & Replace Entire Ramp. Surveyor Notes: N/A PROW/ADA: Not Found, R304.2.2, R304.5.3
