# Access Compliance Report

## Public Rights-of-Way

### (Curb Ramps)

Intersection ID: 3180	Main Street: JOHNSTON_OEHLER_RD	Cross Street: SONG_SPARROW_LN	Location:	N
ADA ID: 8D14883A5B1E	Ramp Type: PerpDiag	Initial Pass/Fail: Fail	Overall Compliance: No	Severity Score: 25
Codes/Mitigation Info/Possible Solution		Field Measurements/Component Compliance

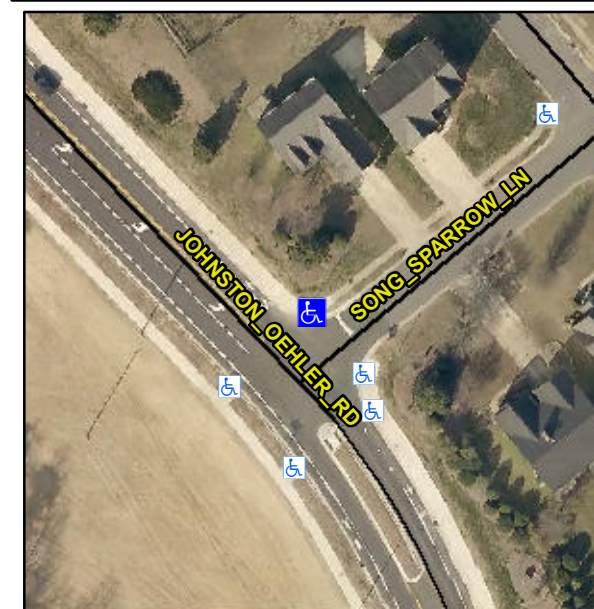
Compliance	Description	Data	Compliance	Description	Data
N/A	Ramp Length (in)	12.0	No	Ramp Slope (%)	12.6
Yes	Ramp Width (in)	48.0	Yes	Ramp XSlope (%)	0.7
N/A	Flare Type LT	N/A	N/A	Flare Type RT	N/A
N/A	Flare Slope LT (%)	N/A	N/A	Flare Slope RT (%)	N/A
N/A	Flare Traversable LT?	N/A	N/A	Flare Traversable RT?	N/A
N/A	Landing Length (in)	N/A	N/A	DWS Provided?	N/A
N/A	Landing Width (in)	N/A	N/A	DWS Contrast?	N/A
N/A	Landing Slope (%)	N/A	N/A	DWS Length (in)	N/A
N/A	Landing X Slope (%)	N/A	N/A	DWS Full Width?	N/A
N/A	Landing Curb? (Y/N)	N/A	N/A	DWS Offset (in)	N/A
N/A	Shared Landing?	N/A			
N/A	Gutter Ponding?	N/A	N/A	Gutter Slope (%)	N/A
N/A	Gutter Lip Ht (in)	N/A	N/A	Gutter X Slope (%)	N/A
N/A	Painted X Walk1?	No	N/A	Painted X Walk2?	No
	X Walk 1 Direction	To SW		X Walk 2 Direction	To SE
N/A	X Walk 1 Width (in)	N/A	N/A	X Walk 2 Width (in)	N/A
	X Walk 1 Slope (%)	0.3		X Walk 2 Slope (%)	0.6
	X Walk 1 X Slope (%)	0.5		X Walk 2 X Slope (%)	1.2

N/A	Ramp inside XWalk1?	N/A	N/A	Ramp inside XWalk2?	N/A
	Road Slope (%)	0.6	N/A	Clear Space?	N/A
	Road X Slope (%)	0.1	N/A	Clear Space to XWalk (in)	N/A
N/A	Any Obstructions?	N/A	N/A	Storm Grate/Utility Hazard?	N/A
	Obstruction Type			Storm Grate/Utility Type	
		N/A			N/A
			Yes	Surface Condition? (G/P)	Good

Possible Solutions:

**Remove & Replace Curb Ramp With Two New Directional Ramps or Equivalent.**
