Access Compliance Report

Public Rights-of-Way

(Curb Ramps)

Intersection ID: 30154	Main Street: ALSTON_HILL_DR	Cross Street: RED_BUD_CR	Location: NE
ADA ID: 8D223242D7D5	Ramp Type: BlendTrans1	Initial Pass/Fail: Fail	Overall Compliance: No
		Severity Score: 10

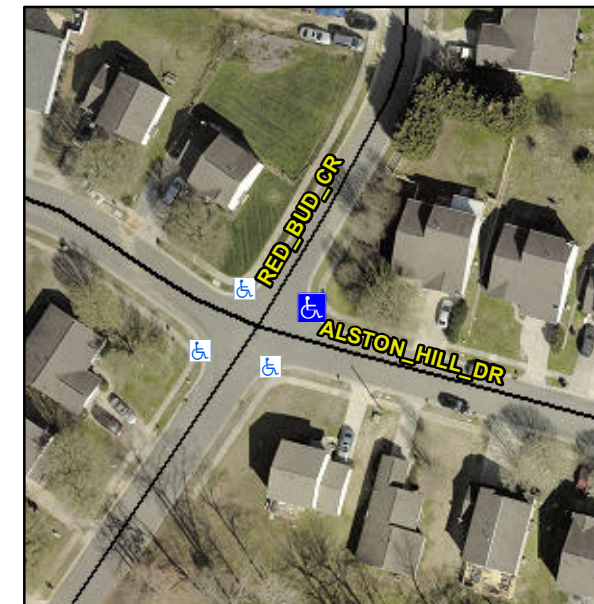
Not Found, R304.5.1, R304.5.3

Compliance	Description	Data	Compliance	Description	Data
N/A	Ramp Length (in)	39.5	Yes	BlendTrans Slope (%)	3.8
No	Ramp Width (in)	45.0	No	BlendTrans XSlope (%)	3.6
N/A	Flare Type LT	N/A	N/A	Flare Type RT	N/A
N/A	Flare Slope LT (%)	N/A	N/A	Flare Slope RT (%)	N/A
N/A	Flare Traversable LT?	N/A	N/A	Flare Traversable RT?	N/A
N/A	Landing Length (in)	N/A	N/A	DWS Provided?	N/A
N/A	Landing Width (in)	N/A	N/A	DWS Contrast?	N/A
N/A	Landing Slope (%)	N/A	N/A	DWS Length (in)	N/A
N/A	Landing X Slope (%)	N/A	N/A	DWS Full Width?	N/A
N/A	Landing Curb? (Y/N)	N/A	N/A	DWS Offset (in)	N/A
N/A	Shared Landing?	N/A			
N/A	Gutter Ponding?	Yes	N/A	Gutter Slope (%)	N/A
N/A	Gutter Lip Ht (in)	1.0	N/A	Gutter X Slope (%)	N/A
N/A	Painted X Walk1?	No	N/A	Painted X Walk2?	No
	X Walk 1 Direction	To NW		X Walk 2 Direction	To SW
	X Walk 1 Width (in)	N/A		X Walk 2 Width (in)	N/A
	X Walk 1 Slope (%)	5.1		X Walk 2 Slope (%)	4.2
	X Walk 1 X Slope (%)	3.1		X Walk 2 X Slope (%)	4.9

N/A	Ramp inside XWalk1?	N/A	N/A	Ramp inside XWalk2?	N/A
	Road Slope (%)	0.4		Clear Space?	N/A
	Road X Slope (%)	7.7	N/A	Clear Space to XWalk (in)	N/A
N/A	Any Obstructions?	N/A	N/A	Storm Grate/Utility Hazard?	N/A
	Obstruction Type			Storm Grate/Utility Type	
		N/A			N/A
			Yes	Surface Condition? (G/P)	Good
			No	Curb Slope (%)	7.1

Remove & Replace Curb Ramp With Two New Directional Ramps or Equivalent.
