Access Compliance Report

Public Rights-of-Way

(Curb Ramps)

Intersection ID: 24499	Main Street: BECKMORE_PL	Cross Street: SAINTFIELD_PL	Location: NE
ADA ID: 8D31171EFDA8	Ramp Type: Perp	Initial Pass/Fail: Fail	Overall Compliance: No
Severity Score: 13.75			
Codes/Mitigation Info/Possible Solution		Field Measurements/Component Compliance

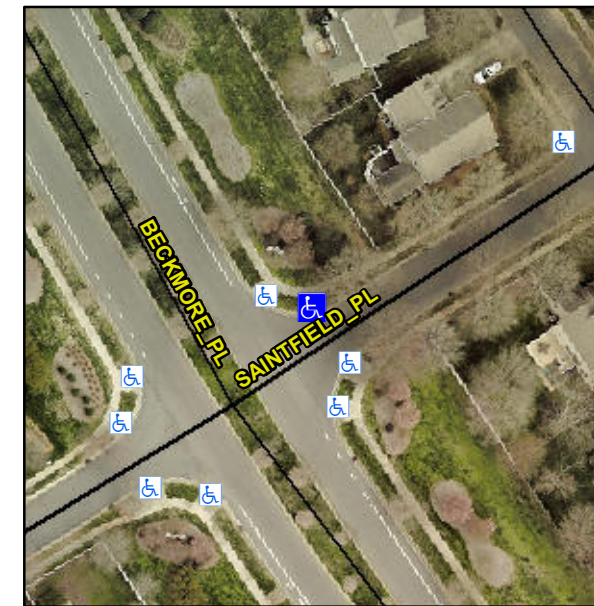
Not Found, R304.2.2, R304.5.3

Compliance	Description	Data	Compliance	Description	Data
N/A	Ramp Length (in)	98.0	No	Ramp Slope (%)	9.8
Yes	Ramp Width (in)	66.0	No	Ramp XSlope (%)	2.4
N/A	Flare Type LT	N/A	N/A	Flare Type RT	N/A
N/A	Flare Slope LT (%)	N/A	N/A	Flare Slope RT (%)	N/A
N/A	Flare Traversable LT?	N/A	N/A	Flare Traversable RT?	N/A
N/A	Landing Length (in)	N/A	N/A	DWS Provided?	N/A
N/A	Landing Width (in)	N/A	N/A	DWS Contrast?	N/A
N/A	Landing Slope (%)	N/A	N/A	DWS Length (in)	N/A
N/A	Landing X Slope (%)	N/A	N/A	DWS Full Width?	N/A
N/A	Landing Curb? (Y/N)	N/A	N/A	DWS Offset (in)	N/A
N/A	Shared Landing?	N/A			
N/A	Gutter Ponding?	N/A	N/A	Gutter Slope (%)	N/A
N/A	Gutter Lip Ht (in)	N/A	N/A	Gutter X Slope (%)	N/A
N/A	Painted X Walk1?	No	N/A	Painted X Walk2?	N/A
	X Walk 1 Direction	To S		X Walk 2 Direction	N/A
N/A	X Walk 1 Width (in)	N/A	N/A	X Walk 2 Width (in)	N/A
	X Walk 1 Slope (%)	6.0		X Walk 2 Slope (%)	N/A
	X Walk 1 X Slope (%)	2.7		X Walk 2 X Slope (%)	N/A

Possible Solutions:

Remove & Replace Entire Ramp.

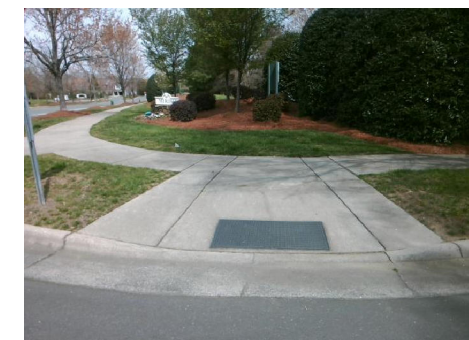
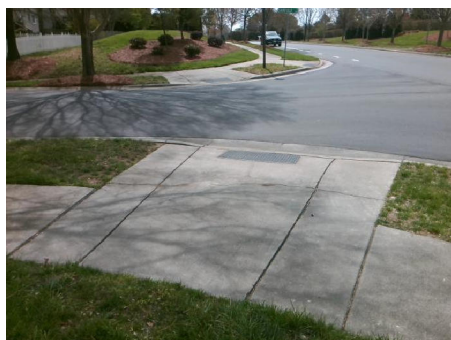
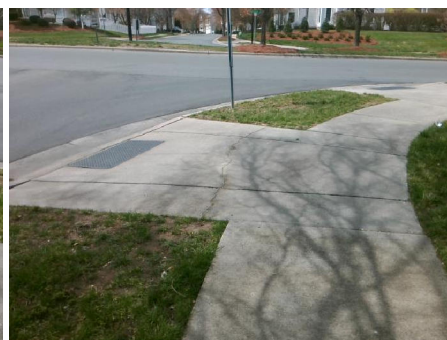
N/A	Ramp inside XWalk1?	N/A	N/A	Ramp inside XWalk2?	N/A
	Road Slope (%)	N/A	N/A	Clear Space?	N/A
	Road X Slope (%)	N/A	N/A	Clear Space to XWalk (in)	N/A
N/A	Any Obstructions?	N/A	N/A	Storm Grate/Utility Hazard?	N/A
	Obstruction Type			Storm Grate/Utility Type	
		N/A			N/A
			Yes	Surface Condition? (G/P)	Good
