Access Compliance Report Public Rights-of-Way (Curb Ramps)

| Intersection ID: 46372 | Main Street: ROYAL_CASTLE_CT | Cross Street: STRONVAR_HOUSE_LN | Location: S |
| ADA ID: 8D374230C900 | Ramp Type: Perp | Initial Pass/Fail: Fail | Overall Compliance: No Severity Score: 10 |

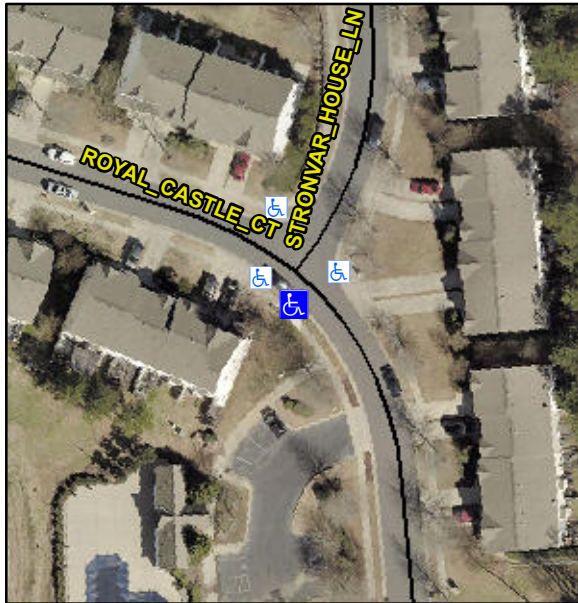
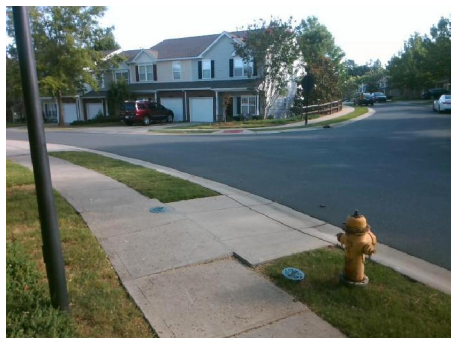
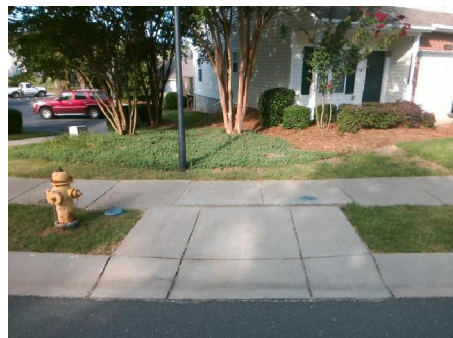
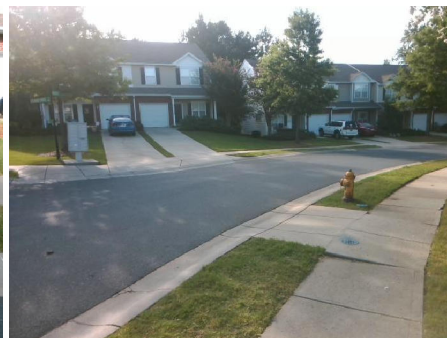
Not Found, R304.5.1

| Compliance | Description | Data | Compliance | Description | Data |
|---|---|---|---|---|---|
| N/A | Ramp Length (in) | 47.0 | Yes | Ramp Slope (%) | 7.2 |
| No | Ramp Width (in) | 47.0 | Yes | Ramp XSlope (%) | 4.0 |

Remove & Replace Entire Ramp.

Total Cost: \$ 1850.00
