Access Compliance Report

Public Rights-of-Way

(Curb Ramps)

Intersection ID: 12519	Main Street: E_6TH_ST	Cross Street: N_CALDWELL_ST	Location: S
ADA ID: 8D3810AEE38D	Ramp Type: BlendTrans1	Initial Pass/Fail: Fail	Overall Compliance: No
		Severity Score: 10

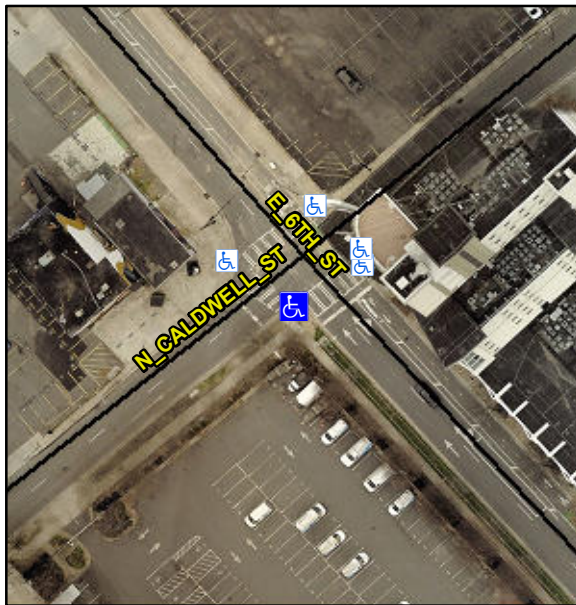
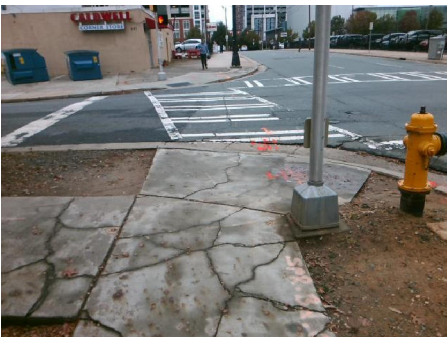
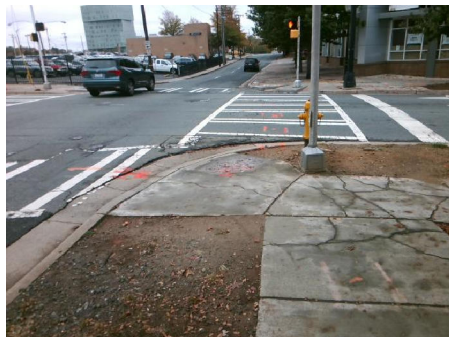
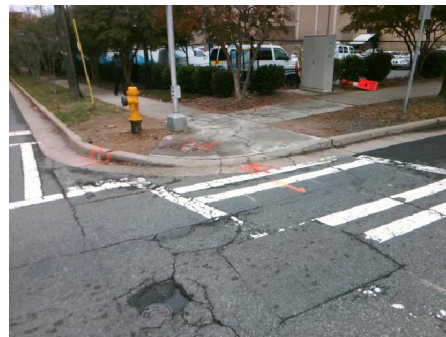
Not Found, R304.5.1, R304.5.3

Compliance	Description	Data	Compliance	Description	Data
N/A	Ramp Length (in)	75.0	Yes	BlendTrans Slope (%)	0.8
No	Ramp Width (in)	47.0	No	BlendTrans XSlope (%)	5.0
N/A	Flare Type LT	N/A	N/A	Flare Type RT	N/A
N/A	Flare Slope LT (%)	N/A	N/A	Flare Slope RT (%)	N/A
N/A	Flare Traversable LT?	N/A	N/A	Flare Traversable RT?	N/A
N/A	Landing Length (in)	N/A	N/A	DWS Provided?	N/A
N/A	Landing Width (in)	N/A	N/A	DWS Contrast?	N/A
N/A	Landing Slope (%)	N/A	N/A	DWS Length (in)	N/A
N/A	Landing X Slope (%)	N/A	N/A	DWS Full Width?	N/A
N/A	Landing Curb? (Y/N)	N/A	N/A	DWS Offset (in)	N/A
N/A	Shared Landing?	N/A			
N/A	Gutter Ponding?	Yes	N/A	Gutter Slope (%)	N/A
N/A	Gutter Lip Ht (in)	2.0	N/A	Gutter X Slope (%)	N/A
N/A	Painted X Walk1?	Yes	N/A	Painted X Walk2?	Yes
	X Walk 1 Direction	To NE		X Walk 2 Direction	To NW
	X Walk 1 Width (in)	102.5		X Walk 2 Width (in)	101.5
	X Walk 1 Slope (%)	0.5		X Walk 2 Slope (%)	4.0
	X Walk 1 X Slope (%)	6.2		X Walk 2 X Slope (%)	0.3

N/A	Ramp inside XWalk1?	Yes	N/A	Ramp inside XWalk2?	Yes
	Road Slope (%)	1.1		Clear Space?	N/A
	Road X Slope (%)	4.2	N/A	Clear Space to XWalk (in)	N/A
N/A	Any Obstructions?	N/A	N/A	Storm Grate/Utility Hazard?	N/A
	Obstruction Type			Storm Grate/Utility Type	
		N/A			N/A
			Yes	Surface Condition? (G/P)	Good
			No	Curb Slope (%)	16.0

Remove & Replace Curb Ramp With Two New Directional Ramps or Equivalent.
