Access Compliance Report

Public Rights-of-Way

(Curb Ramps)

Intersection ID: 10020377	Main Street: BALLANTYNE CORPORATE PL	Cross Street: N/A	Location: NW
ADA ID: 8D396212162D	Ramp Type: Perp	Initial Pass/Fail: Fail	Overall Compliance: No
Severity Score: 13.75			
Codes/Mitigation Info/Possible Solution		Field Measurements/Component Compliance

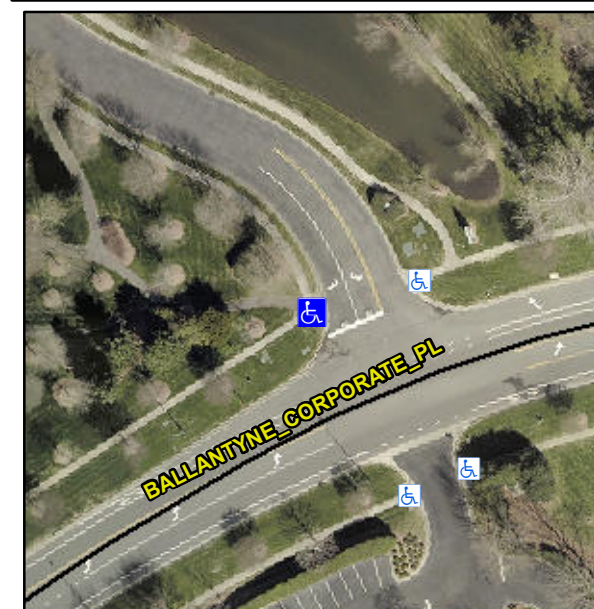
Not Found, R304.2.2, R304.5.3

Compliance	Description	Data	Compliance	Description	Data
N/A	Ramp Length (in)	140.0	No	Ramp Slope (%)	9.0
Yes	Ramp Width (in)	48.0	No	Ramp XSlope (%)	4.3
N/A	Flare Type LT	N/A	N/A	Flare Type RT	N/A
N/A	Flare Slope LT (%)	N/A	N/A	Flare Slope RT (%)	N/A
N/A	Flare Traversable LT?	N/A	N/A	Flare Traversable RT?	N/A
N/A	Landing Length (in)	N/A	N/A	DWS Provided?	N/A
N/A	Landing Width (in)	N/A	N/A	DWS Contrast?	N/A
N/A	Landing Slope (%)	N/A	N/A	DWS Length (in)	N/A
N/A	Landing X Slope (%)	N/A	N/A	DWS Full Width?	N/A
N/A	Landing Curb? (Y/N)	N/A	N/A	DWS Offset (in)	N/A
N/A	Shared Landing?	N/A			
N/A	Gutter Ponding?	N/A	N/A	Gutter Slope (%)	N/A
N/A	Gutter Lip Ht (in)	N/A	N/A	Gutter X Slope (%)	N/A
N/A	Painted X Walk1?	No	N/A	Painted X Walk2?	N/A
	X Walk 1 Direction	To E		X Walk 2 Direction	N/A
N/A	X Walk 1 Width (in)	N/A	N/A	X Walk 2 Width (in)	N/A
	X Walk 1 Slope (%)	2.8		X Walk 2 Slope (%)	N/A
	X Walk 1 X Slope (%)	1.6		X Walk 2 X Slope (%)	N/A

N/A	Ramp inside XWalk1?	N/A	N/A	Ramp inside XWalk2?	N/A
	Road Slope (%)	N/A	N/A	Clear Space?	N/A
	Road X Slope (%)	N/A	N/A	Clear Space to XWalk (in)	N/A
N/A	Any Obstructions?	N/A	N/A	Storm Grate/Utility Hazard?	N/A
	Obstruction Type			Storm Grate/Utility Type	
		N/A			N/A
		Yes		Surface Condition? (G/P)	Good

Remove & Replace Entire Ramp.

Total Cost: \$ 1850.00
