Intersection ID: 30165	Main Street: BIESTERFIELD_DR	Cross Street: OLDE_ENGLISH_DR	Location:	NW
ADA ID: 8D3F35E8C753	Ramp Type: PerpDiag	Initial Pass/Fail: Fail	Overall Compliance: No	Severity Score: 21.25

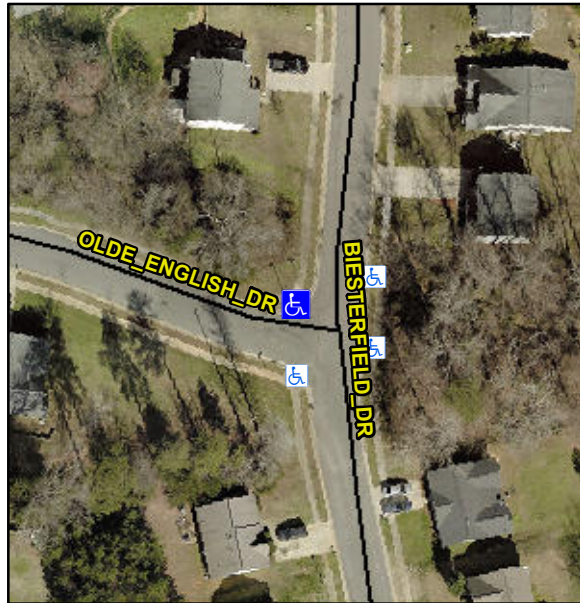
**Not Found, R304.5.1, R304.5.3**

Compliance	Description	Data	Compliance	Description	Data
N/A	Ramp Length (in)	44.0	Yes	Ramp Slope (%)	6.6
No	Ramp Width (in)	47.5	No	Ramp XSlope (%)	5.3
N/A	Flare Type LT	N/A	N/A	Flare Type RT	N/A
N/A	Flare Slope LT (%)	N/A	N/A	Flare Slope RT (%)	N/A
N/A	Flare Traversable LT?	N/A	N/A	Flare Traversable RT?	N/A
N/A	Landing Length (in)	N/A	N/A	DWS Provided?	N/A
N/A	Landing Width (in)	N/A	N/A	DWS Contrast?	N/A
N/A	Landing Slope (%)	N/A	N/A	DWS Length (in)	N/A
N/A	Landing X Slope (%)	N/A	N/A	DWS Full Width?	N/A
N/A	Landing Curb? (Y/N)	N/A	N/A	DWS Offset (in)	N/A
N/A	Shared Landing?	N/A			
N/A	Gutter Ponding?	N/A	N/A	Gutter Slope (%)	N/A
N/A	Gutter Lip Ht (in)	N/A	N/A	Gutter X Slope (%)	N/A
N/A	Painted X Walk1?	No	N/A	Painted X Walk2?	No
	X Walk 1 Direction	To SW		X Walk 2 Direction	To NE
N/A	X Walk 1 Width (in)	N/A	N/A	X Walk 2 Width (in)	N/A
	X Walk 1 Slope (%)	5.0		X Walk 2 Slope (%)	4.0
	X Walk 1 X Slope (%)	0.2		X Walk 2 X Slope (%)	3.5

N/A	Ramp inside XWalk1?	N/A	N/A	Ramp inside XWalk2?	N/A
	Road Slope (%)	1.7	N/A	Clear Space?	N/A
	Road X Slope (%)	5.8	N/A	Clear Space to XWalk (in)	N/A
N/A	Any Obstructions?	N/A	N/A	Storm Grate/Utility Hazard?	N/A
	Obstruction Type			Storm Grate/Utility Type	
		N/A			N/A
			Yes	Surface Condition? (G/P)	Good

**Remove & Replace Curb Ramp With Two New Directional Ramps or Equivalent.**

Total Cost: \$ 3200.00
