Access Compliance Report

Public Rights-of-Way

(Curb Ramps)

Intersection ID: 9655	Main Street: N_GRAHAM_ST	Cross Street: CONCORDIA_AV	Location: S
ADA ID: 8D452C4F2F2B	Ramp Type: PerpDiag	Initial Pass/Fail: Fail	Overall Compliance: No
Severity Score: 27.5			
Codes/Mitigation Info/Possible Solution		Field Measurements/Component Compliance

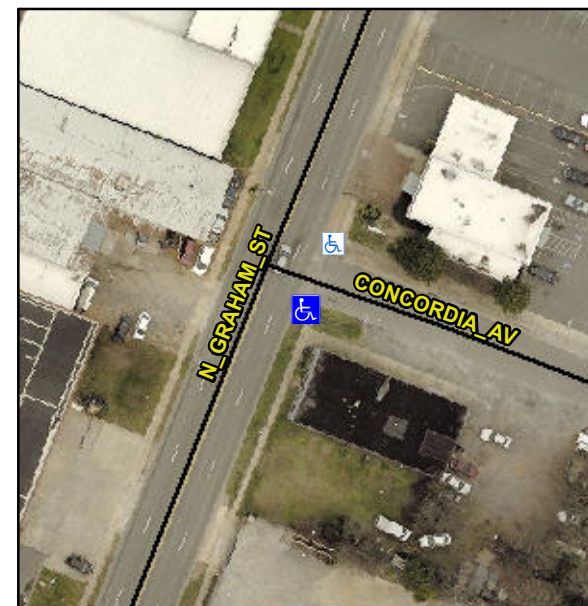
Compliance	Description	Data	Compliance	Description	Data
N/A	Ramp Length (in)	90.0	No	Ramp Slope (%)	8.7
Yes	Ramp Width (in)	64.0	Yes	Ramp XSlope (%)	1.6
N/A	Flare Type LT	N/A	N/A	Flare Type RT	N/A
N/A	Flare Slope LT (%)	N/A	N/A	Flare Slope RT (%)	N/A
N/A	Flare Traversable LT?	N/A	N/A	Flare Traversable RT?	N/A
N/A	Landing Length (in)	N/A	N/A	DWS Provided?	N/A
N/A	Landing Width (in)	N/A	N/A	DWS Contrast?	N/A
N/A	Landing Slope (%)	N/A	N/A	DWS Length (in)	N/A
N/A	Landing X Slope (%)	N/A	N/A	DWS Full Width?	N/A
N/A	Landing Curb? (Y/N)	N/A	N/A	DWS Offset (in)	N/A
N/A	Shared Landing?	N/A			
N/A	Gutter Ponding?	N/A	N/A	Gutter Slope (%)	N/A
N/A	Gutter Lip Ht (in)	1.5	N/A	Gutter X Slope (%)	N/A
N/A	Painted X Walk1?	No	N/A	Painted X Walk2?	No
	X Walk 1 Direction	To NE		X Walk 2 Direction	To NW
N/A	X Walk 1 Width (in)	N/A	N/A	X Walk 2 Width (in)	N/A
	X Walk 1 Slope (%)	1.5		X Walk 2 Slope (%)	5.5
	X Walk 1 X Slope (%)	3.0		X Walk 2 X Slope (%)	1.3

N/A	Ramp inside XWalk1?	N/A	N/A	Ramp inside XWalk2?	N/A
	Road Slope (%)	1.8	N/A	Clear Space?	N/A
	Road X Slope (%)	4.6	N/A	Clear Space to XWalk (in)	N/A
N/A	Any Obstructions?	N/A	N/A	Storm Grate/Utility Hazard?	N/A
	Obstruction Type			Storm Grate/Utility Type	
		N/A			N/A
		No		Surface Condition? (G/P)	Poor

Possible Solutions:

Remove & Replace Curb Ramp With Two New Directional Ramps or Equivalent.
