Access Compliance Report

Public Rights-of-Way

(Curb Ramps)

| Intersection ID: 44242 | Main Street: KIEV_DR | Cross Street: SUNSET_RD | Location: W |

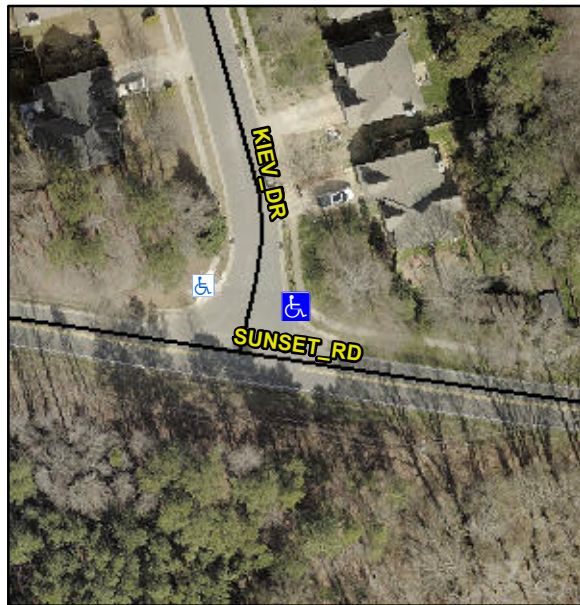
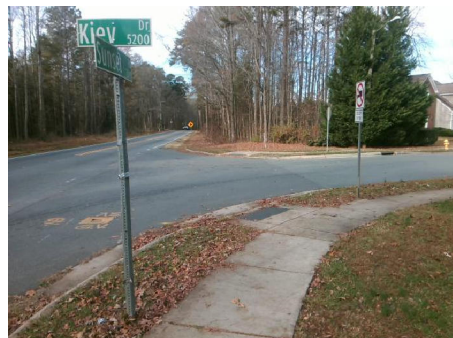
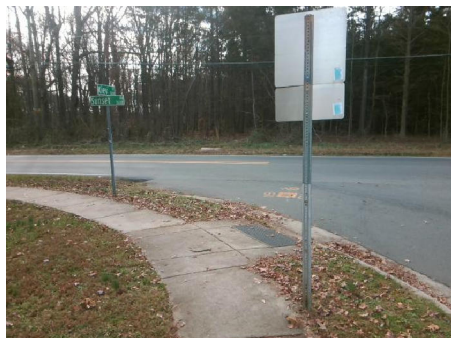
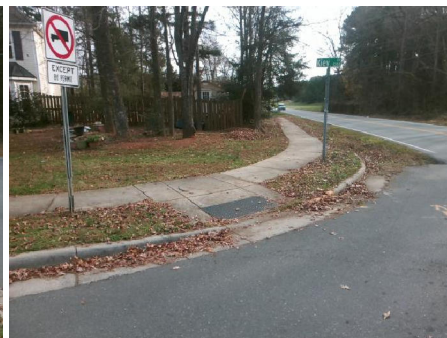
Not Found, R304.5.1, R304.2.2, R304.5.3

| Compliance | Description | Data | Compliance | Description | Data |
|---|---|---|---|---|---|
| N/A | Ramp Length (in) | 48.0 | No | Ramp Slope (%) | 9.3 |
| No | Ramp Width (in) | 46.0 | No | Ramp XSlope (%) | 2.2 |

Remove & Replace Entire Ramp.
