# Access Compliance Report

## Public Rights-of-Way

### (Curb Ramps)

Intersection ID: 50666	Main Street: SPRINGPOINT_LN	Cross Street: SAMUEL_NEEL_RD	Location: SW
ADA ID: 8D5BFB0440F5	Ramp Type: PerpDiag	Initial Pass/Fail: Fail	Overall Compliance: No
Severity Score: 12.5			
Codes/Mitigation Info/Possible Solution		Field Measurements/Component Compliance

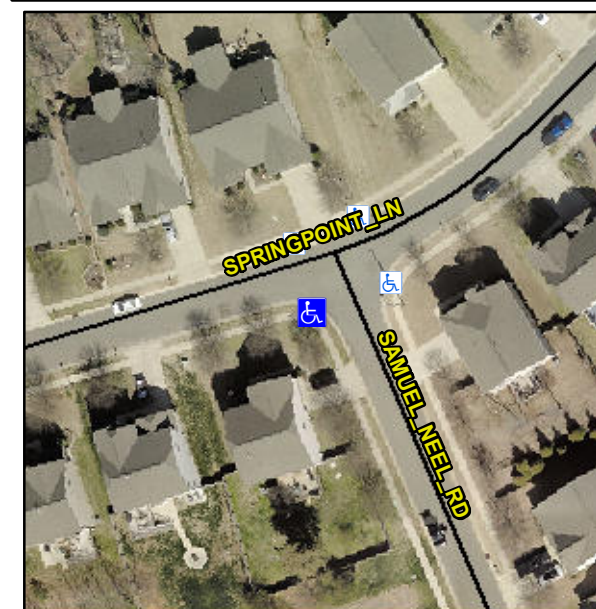
Compliance	Description	Data	Compliance	Description	Data
N/A	Ramp Length (in)	47.0	Yes	Ramp Slope (%)	7.3
Yes	Ramp Width (in)	48.0	No	Ramp XSlope (%)	5.9
N/A	Flare Type LT	N/A	N/A	Flare Type RT	N/A
N/A	Flare Slope LT (%)	N/A	N/A	Flare Slope RT (%)	N/A
N/A	Flare Traversable LT?	N/A	N/A	Flare Traversable RT?	N/A
N/A	Landing Length (in)	N/A	N/A	DWS Provided?	N/A
N/A	Landing Width (in)	N/A	N/A	DWS Contrast?	N/A
N/A	Landing Slope (%)	N/A	N/A	DWS Length (in)	N/A
N/A	Landing X Slope (%)	N/A	N/A	DWS Full Width?	N/A
N/A	Landing Curb? (Y/N)	N/A	N/A	DWS Offset (in)	N/A
N/A	Shared Landing?	N/A			
N/A	Gutter Ponding?	N/A	N/A	Gutter Slope (%)	N/A
N/A	Gutter Lip Ht (in)	N/A	N/A	Gutter X Slope (%)	N/A
N/A	Painted X Walk1?	No	N/A	Painted X Walk2?	No
	X Walk 1 Direction	To NE		X Walk 2 Direction	To NW
N/A	X Walk 1 Width (in)	N/A	N/A	X Walk 2 Width (in)	N/A
	X Walk 1 Slope (%)	7.5		X Walk 2 Slope (%)	5.8
	X Walk 1 X Slope (%)	2.2		X Walk 2 X Slope (%)	6.3

N/A	Ramp inside XWalk1?	N/A	N/A	Ramp inside XWalk2?	N/A
	Road Slope (%)	1.5	N/A	Clear Space?	N/A
	Road X Slope (%)	10.4	N/A	Clear Space to XWalk (in)	N/A
N/A	Any Obstructions?	N/A	N/A	Storm Grate/Utility Hazard?	N/A
	Obstruction Type			Storm Grate/Utility Type	
		N/A			N/A
			Yes	Surface Condition? (G/P)	Good

**Remove & Replace Curb Ramp With Two New Directional Ramps or Equivalent.**

**R304.5.3**
