Access Compliance Report Public Rights-of-Way (Curb Ramps)

Main Street: CAMDEN RD **Cross Street: EAST BV** Location: Intersection ID: 13985 SW

Initial Pass/Fail: Fail **Overall Compliance: No ADA ID: 8D6777AFF1B7** Ramp Type: Directional1 Severity Score: 13.75

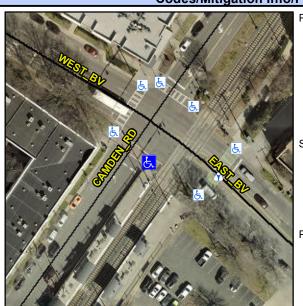
Possible Solution	Field Measurements/Component Compliance					
Possible Solutions:	Compliance Description		Data	Compliance Description		
Remove & Replace Entire Ramp.	N/A	Ramp Length (in)	108.0	N/A	Grade	e Break?
·	Yes	Ramp Width (in)	118.0	N/A	Grade	e Break Slope (
	No	Ramp Slope (%)	9.8	N/A	Grade	e Break XSlope
	Yes	Ramp XSlope (%)	2.5			
	N/A	Flare Type LT	N/A	N/A	Flare	Type RT
	N/A	Flare Slope LT (%)	N/A	N/A	Flare	Slope RT (%)
Surveyor Notes:	N/A	Flare Traversable LT?	N/A	N/A	Flare	Traversable R
XWALK PAVERS	N/A	Landing Length (in)	0.0	N/A	DWS	Provided?
	N/A	Landing Width (in)	0.0	N/A	DWS	Contrast?
	N/A	Landing Slope (%)	0.0	N/A	DWS	Length (in)
	N/A	Landing X Slope (%)	0.0	N/A	DWS	Full Width?
PROW/ADA:	N/A	Landing Curb? (Y/N)	N/A	N/A	DWS	Offset LT (in)
R304.2.2	N/A	Shared Landing?	N/A	N/A	DWS	Offset RT (in)
	N/A	Gutter Ponding?	0.0	N/A	Gutte	er Slope (%)
	N/A	Gutter Lip Ht (in)	0.0	N/A	Gutte	er X Slope (%)

N/A	Painted X Walk1?	Yes		Road	Slope (%)
		X Walk 1 Direction	To NW		Road	X Slope (%)
		X Walk 1 Width (in)	127.0		Clear	Space?
		X Walk 1 Slope (%)	2.5	N/A	Clear	Space to XWa
		X Walk 1 X Slope (%)	7.3	N/A	Storm	n Grate/Utility H
	N/A	Ramp inside XWalk1?	Yes		Storm	n Grate/Utility T
