Access Compliance Report Public Rights-of-Way (Curb Ramps)

Intersection ID: 4086 Main Street: CLAYBROOKE_DR Cross Street: SANRIDGE_WIND_LN Location: SE **Overall Compliance: No** ADA ID: 8D6A701449CA Ramp Type: Perp Initial Pass/Fail: Fail Severity Score: 46.25

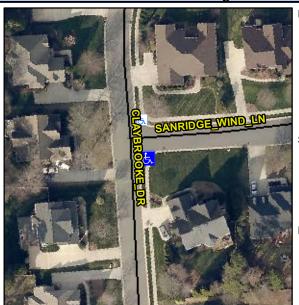
Field Measurements/Component Compliance								
Comp	liance Description	Data	Compl	liance	Description	Data		
N/A	Ramp Length (in)	96.0	No	Ramp	Slope (%)	9.1		
No	Ramp Width (in)	43.5	No	No Ramp XSlope (%)		12.4		
N/A	Flare Type LT	N/A	N/A	N/A Flare Type RT		N/A		
N/A	Flare Slope LT (%)	N/A	N/A Flare Slope RT (%)		N/A			
N/A	Flare Traversable LT?	N/A	N/A	N/A Flare Traversable RT?		N/A		
N/A	Landing Length (in)	N/A	N/A	DWS	Provided?	N/A		
N/A	Landing Width (in)	N/A	N/A	DWS	Contrast?	N/A		
N/A	Landing Slope (%)	N/A	N/A	DWS	Length (in)	N/A		
N/A	Landing X Slope (%)	N/A	N/A	DWS	Full Width?	N/A		
N/A	Landing Curb? (Y/N)	N/A	N/A	DWS	Offset (in)	N/A		
N/A	Shared Landing?	N/A						
N/A	Gutter Ponding?	N/A	N/A	Gutter	Slope (%)	N/A		
N/A	Gutter Lip Ht (in)	1.0	N/A	Gutter	X Slope (%)	N/A		
N/A	Painted X Walk1?	No	N/A	Painte	ed X Walk2?	N/A		
	X Walk 1 Direction	To N		X Wal	k 2 Direction	N/A		
N/A	X Walk 1 Width (in)	N/A	N/A	X Wal	k 2 Width (in)	N/A

X Walk 1 Slope (%)	0.3		X Wal	k 2 Slope (%)	N/A		
	X Walk 1 X Slope (%)	5.5		X Wal	k 2 X Slope (%)	N/A		
N/A	Ramp inside XWalk1?	N/A	N/A	Ramp	inside XWalk2?	N/A		
	Road Slope (%)	N/A	N/A	Clear	Space?	N/A		
	Road X Slope (%)	N/A	N/A	Clear	Space to XWalk (in)	N/A		
N/A	Any Obstructions?	N/A	N/A	Storm	Grate/Utility Hazard?	N/A		
	Obstruction Type			Storm	Grate/Utility Type			
		N/A				N/A		
			Yes	Surfac	ce Condition? (G/P)	Good		
	Special Control

CSSIDIC COIGUOII					
Possible Solutions:					
Remove & Replace Entire Ramp.					
Surveyor Notes:					
N/A					
PROW/ADA:					
Not Found, R304.5.1, R304.2.2, R304.5.3					
1,004.0.0
