## Access Compliance Report Public Rights-of-Way (Curb Ramps)

Intersection ID: 30082 Main Street: VILLAGE\_SHOPPING\_CENTERCORRESINStreet: J\_W\_CLAY\_BV Location: SE

ADA ID: 8D6B51AD407A Ramp Type: PerpDiag Initial Pass/Fail: Fail Overall Compliance: No Severity Score: 21.25

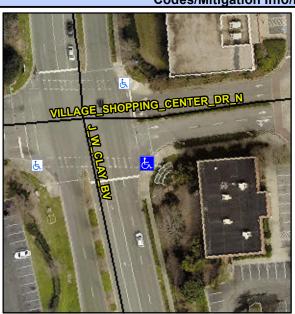
Street 1 Name VILLAGE SHOPPING CENTER DR N
Stop Condition-Street 2 Signal
Street 2 Name J W CLAY BV
Stop Condition-Street 1 Signal

PROW/ADA:
Not Found, R304.5.1, R304.2.2

| Field Measurements/Component Compliance | | | | | |
|---|---|---|---|---|---|
| N/A | Ramp Length (in) | 56.0 | No | Ramp Slope (%) | 8.4 |
| No | Ramp Width (in) | 38.5 | Yes | Ramp XSlope (%) | 1.7 |

Remove & Replace Curb Ramp With
Two New Directional Ramps or
Equivalent.
