# Access Compliance Report

## Public Rights-of-Way

### (Curb Ramps)

Intersection ID: 9645	Main Street: FRANKLIN_AV	Cross Street: GRIMES_ST	Location:	E
ADA ID: 8D703D15CC5B	Ramp Type: Combination1	Initial Pass/Fail: Fail	Overall Compliance: No	Severity Score: 46.25

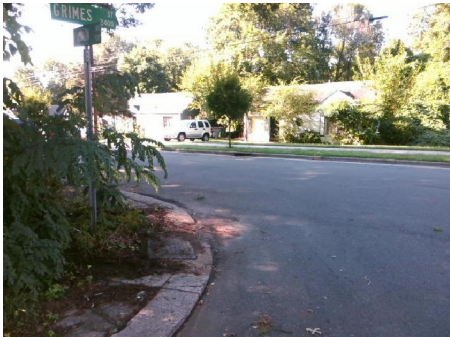
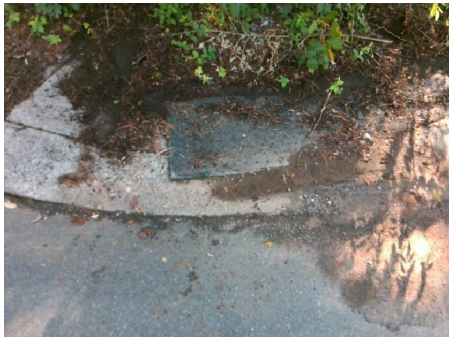
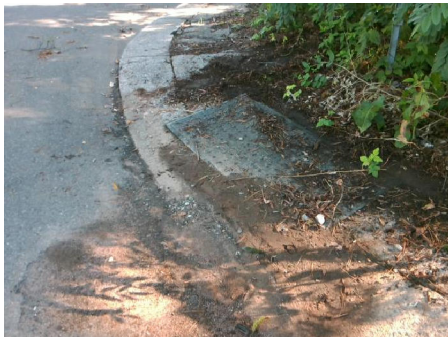
Possible Solutions:			<b>Compliance</b>	<b>Description</b>	<b>Data</b>	<b>Compliance</b>	<b>Description</b>	<b>Data</b>
	<b>Remove &amp; Replace Entire Ramp.</b>			N/A	Ramp Length LT (in)	15.0	N/A	Ramp Length RT (in)	32.0
				No	Ramp Width LT (in)	38.5	No	Ramp Width RT (in)	38.0
				No	Ramp Slope LT (%)	13.7	Yes	Ramp Slope RT (%)	5.0
				No	Ramp XSlope LT (%)	6.3	No	Ramp XSlope RT (%)	5.0
				N/A	Ramp Length (in)	36.0	No	Ramp Slope (%)	15.6
				Yes	Ramp Width (in)	48.0	No	Ramp XSlope (%)	3.2
	Surveyor Notes:			N/A	Flare Type LT	N/A	N/A	Flare Type RT	N/A
	<b>HEAVY PONDING</b>			N/A	Flare Slope LT (%)	N/A	N/A	Flare Slope RT (%)	N/A
				N/A	Flare Traversable LT?	N/A	N/A	Flare Traversable RT?	N/A
				N/A	Landing Length (in)	N/A	N/A	DWS Provided?	N/A
				N/A	Landing Width (in)	N/A	N/A	DWS Contrast?	N/A
	PROW/ADA:			N/A	Landing Slope (%)	N/A	N/A	DWS Length (in)	N/A

<b>R304.5.1, R304.2.2, R304.5.3, R304.3.2</b>			N/A	Landing X Slope (%)	N/A	N/A	DWS Full Width?	N/A
				N/A	Landing Curb? (Y/N)	N/A	N/A	DWS Offset (in)	N/A
				N/A	Shared Landing?	N/A			
				N/A	Gutter Ponding?	N/A	N/A	Gutter Slope (%)	N/A
				N/A	Gutter Lip Ht (in)	N/A	N/A	Gutter X Slope (%)	N/A
				N/A	Painted X Walk1?	No	N/A	Painted X Walk2?	N/A
				X Walk 1 Direction	To SW		X Walk 2 Direction	N/A	
				X Walk 1 Width (in)	N/A		X Walk 2 Width (in)	N/A	
				X Walk 1 Slope (%)	2.8		X Walk 2 Slope (%)	N/A	
				X Walk 1 X Slope (%)	2.5		X Walk 2 X Slope (%)	N/A	
			N/A	Ramp inside XWalk1?	N/A	N/A	Ramp inside XWalk2?	N/A	
				Road Slope (%)	N/A		Clear Space?	N/A	
				Road X Slope (%)	N/A	N/A	Clear Space to XWalk (in)	N/A	
						N/A	Any Obstruction?	N/A	
							Obstruction Type	N/A	
						N/A	Storm Grate/Utility Hazard?	N/A	
							Storm Grate/Utility Type	N/A	
						Yes	Surface Condition? (G/P)	Good	
							Curb Slope (%)	N/A
