Access Compliance Report

Public Rights-of-Way

(Curb Ramps)

Intersection ID: 44831	Main Street: ST_JOHNS_CHURCH_RD	Cross Street: DECAPOLIS_DR	Location: NW
ADA ID: 8D7F93CA6D62	Ramp Type: Perp	Initial Pass/Fail: Fail	Overall Compliance: No
Severity Score: 10			
Codes/Mitigation Info/Possible Solution		Field Measurements/Component Compliance

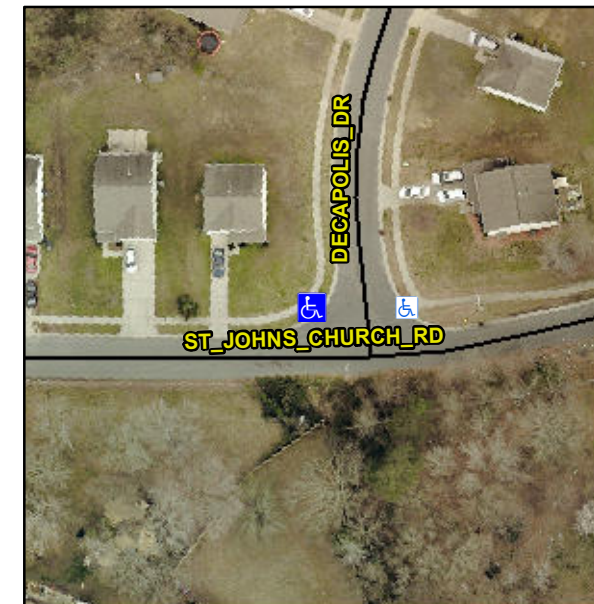
Not Found, R304.5.1, R304.5.3

Compliance	Description	Data	Compliance	Description	Data
N/A	Ramp Length (in)	59.0	Yes	Ramp Slope (%)	6.1
No	Ramp Width (in)	47.0	No	Ramp XSlope (%)	4.2
N/A	Flare Type LT	N/A	N/A	Flare Type RT	N/A
N/A	Flare Slope LT (%)	N/A	N/A	Flare Slope RT (%)	N/A
N/A	Flare Traversable LT?	N/A	N/A	Flare Traversable RT?	N/A
N/A	Landing Length (in)	N/A	N/A	DWS Provided?	N/A
N/A	Landing Width (in)	N/A	N/A	DWS Contrast?	N/A
N/A	Landing Slope (%)	N/A	N/A	DWS Length (in)	N/A
N/A	Landing X Slope (%)	N/A	N/A	DWS Full Width?	N/A
N/A	Landing Curb? (Y/N)	N/A	N/A	DWS Offset (in)	N/A
N/A	Shared Landing?	N/A			
N/A	Gutter Ponding?	N/A	N/A	Gutter Slope (%)	N/A
N/A	Gutter Lip Ht (in)	N/A	N/A	Gutter X Slope (%)	N/A
N/A	Painted X Walk1?	No	N/A	Painted X Walk2?	N/A
	X Walk 1 Direction	To E		X Walk 2 Direction	N/A
N/A	X Walk 1 Width (in)	N/A	N/A	X Walk 2 Width (in)	N/A
	X Walk 1 Slope (%)	4.5		X Walk 2 Slope (%)	N/A
	X Walk 1 X Slope (%)	1.5		X Walk 2 X Slope (%)	N/A

N/A	Ramp inside XWalk1?	N/A	N/A	Ramp inside XWalk2?	N/A
	Road Slope (%)	N/A	N/A	Clear Space?	N/A
	Road X Slope (%)	N/A	N/A	Clear Space to XWalk (in)	N/A
N/A	Any Obstructions?	N/A	N/A	Storm Grate/Utility Hazard?	N/A
	Obstruction Type			Storm Grate/Utility Type	
		N/A			N/A
		Yes		Surface Condition? (G/P)	Good

Possible Solutions:

Remove & Replace Entire Ramp.
