Access Compliance Report

Public Rights-of-Way

(Curb Ramps)

Intersection ID: 21296	Main Street: E_ARROWOOD_RD	Cross Street: OLD_PINEVILLE_RD	Location: NE
ADA ID: 8D8A56AAC9B3	Ramp Type: Directional1	Initial Pass/Fail: Fail	Overall Compliance: No
Severity Score: 12.5			
Codes/Mitigation Info/Possible Solution		Field Measurements/Component Compliance

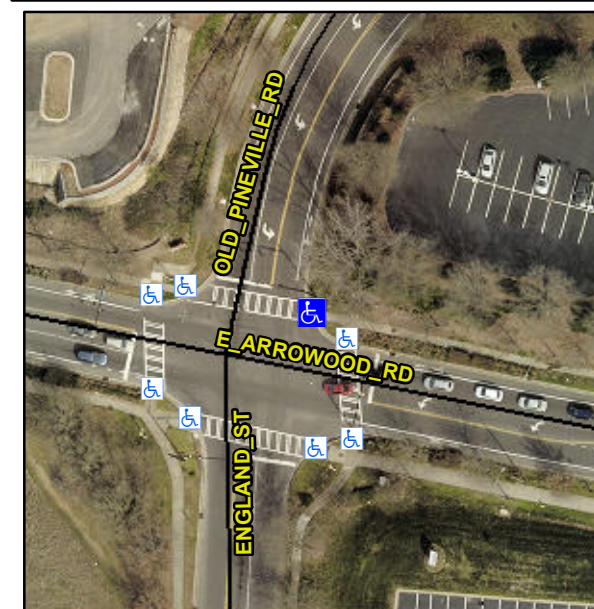
Compliance	Description	Data	Compliance	Description	Data
N/A	Ramp Length (in)	77.0	N/A	Grade Break?	N/A
Yes	Ramp Width (in)	54.0	N/A	Grade Break Slope (%)	0.0
Yes	Ramp Slope (%)	3.6	N/A	Grade Break XSlope (%)	0.0
No	Ramp XSlope (%)	6.4			
N/A	Flare Type LT	N/A	N/A	Flare Type RT	N/A
N/A	Flare Slope LT (%)	N/A	N/A	Flare Slope RT (%)	0.0
N/A	Flare Traversable LT?	N/A	N/A	Flare Traversable RT?	N/A
N/A	Landing Length (in)	0.0	N/A	DWS Provided?	N/A
N/A	Landing Width (in)	0.0	N/A	DWS Contrast?	N/A
N/A	Landing Slope (%)	0.0	N/A	DWS Length (in)	N/A
N/A	Landing X Slope (%)	0.0	N/A	DWS Full Width?	N/A
N/A	Landing Curb? (Y/N)	N/A	N/A	DWS Offset LT (in)	N/A
N/A	Shared Landing?	N/A	N/A	DWS Offset RT (in)	N/A
N/A	Gutter Ponding?	0.0	N/A	Gutter Slope (%)	N/A
N/A	Gutter Lip Ht (in)	0.0	N/A	Gutter X Slope (%)	N/A
N/A	Painted X Walk1?	No		Road Slope (%)	1.3
	X Walk 1 Direction	To W		Road X Slope (%)	1.0
	X Walk 1 Width (in)	N/A		Clear Space?	N/A

X Walk 1 Slope (%)	1.3	N/A	Clear Space to XWalk (in)	N/A
	X Walk 1 X Slope (%)	1.0	N/A	Storm Grate/Utility Hazard?	N/A
N/A	Ramp inside XWalk1?	N/A		Storm Grate/Utility Type	
N/A	Any Obstructions?	N/A			N/A
	Obstruction Type		Yes	Surface Condition? (G/P)	Good
			N/A	Curb Slope (%)	10.5

Possible Solutions:

Remove & Replace Entire Ramp.

PROW/ADA:

R304.5.3
