Access Compliance Report

Public Rights-of-Way

| Intersection ID: 27872 | Main Street: BALLANTYNE_COUNTRY_CLUB_DR | Cross Street: LETHCO_WY | Location: SW |
| ADA ID: 8D8A896FDF61 | Ramp Type: Perp | Initial Pass/Fail: Fail | Overall Compliance: No |

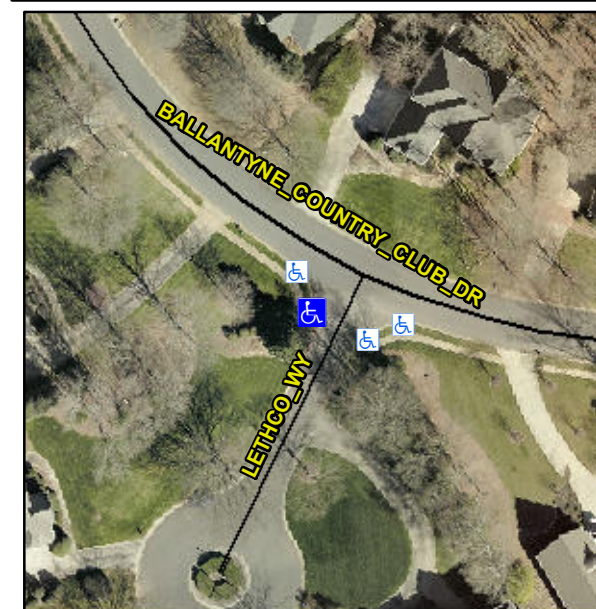
| Severity Score: 10 | | | |

Not Found, R304.5.1, R304.5.3

| Compliance | Description | Data | Compliance | Description | Data |
|---|---|---|---|---|---|
| N/A | Ramp Length (in) | 46.0 | Yes | Ramp Slope (%) | 5.3 |
| No | Ramp Width (in) | 44.0 | No | Ramp XSlope (%) | 3.3 |

Remove & Replace Entire Ramp.
