Access Compliance Report Public Rights-of-Way (Curb Ramps)

Intersection ID: 42457 Main Street: SUNNINGHILL_PARK_RD Cross Street: HONOR_GUARD_AV Location: NE **Overall Compliance: No** ADA ID: 8D8BA0AC2573 Ramp Type: Perp Initial Pass/Fail: Fail **Severity Score:** 47.5

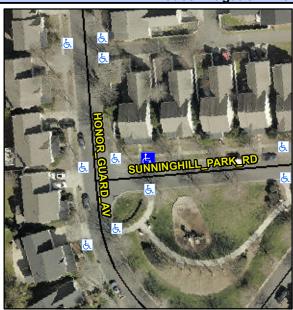
001111	manoc Description	Dutu	ООППР	marioc Description	Dutu
N/A	Ramp Length (in)	75.0	No	Ramp Slope (%)	10.8
No	Ramp Width (in)	26.0	Yes	Ramp XSlope (%)	1.9
N/A	Flare Type LT	N/A	N/A	Flare Type RT	N/A
N/A	Flare Slope LT (%)	N/A	N/A	Flare Slope RT (%)	N/A
N/A	Flare Traversable LT?	N/A	N/A	Flare Traversable RT?	N/A
N/A	Landing Length (in)	N/A	N/A	DWS Provided?	N/A
N/A	Landing Width (in)	N/A	N/A	DWS Contrast?	N/A
N/A	Landing Slope (%)	N/A	N/A	DWS Length (in)	N/A
N/A	Landing X Slope (%)	N/A	N/A	DWS Full Width?	N/A
N/A	Landing Curb? (Y/N)	N/A	N/A	DWS Offset (in)	N/A
N/A	Shared Landing?	N/A			
N/A	Gutter Ponding?	N/A	N/A	Gutter Slope (%)	N/A
N/A	Gutter Lip Ht (in)	N/A	N/A	Gutter X Slope (%)	N/A
N/A	Painted X Walk1?	No	N/A	Painted X Walk2?	N/A
	X Walk 1 Direction	To S		X Walk 2 Direction	N/A
N/A	X Walk 1 Width (in)	N/A	N/A	X Walk 2 Width (in)	N/A
	X Walk 1 Slope (%)	2.3		X Walk 2 Slope (%)	N/A
	X Walk 1 X Slope (%)	1.5		X Walk 2 X Slope (%)	N/A

Remove & Replace Entire Ramp. Surveyor Notes: N/A PROW/ADA: Not Found R304 5 1 R304 2 2

Not i ouiiu,	N304.3.1, N3	J4.Z.Z	•	N/A
				N/A
				N/A
Total Cost:		\$	1850.00	N/A
