## Access Compliance Report Public Rights-of-Way (Curb Ramps)

Intersection ID: 15856Main Street: PARK\_RDCross Street: SALEM\_DRLocation:SEADA ID: 8D8D57995DE8Ramp Type: PerpDiagInitial Pass/Fail: FailOverall Compliance: NoSeverity Score: 12.5

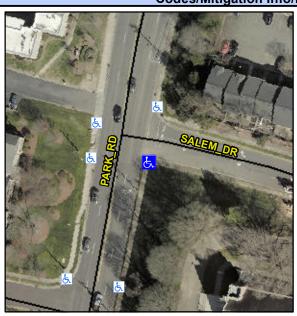
Not Found, R304.5.3

Field Measurements/Component Compilance						
Compliance Description		Data Compliance Description		liance Description	Data	
N/A	Ramp Length (in)	51.0	Yes	Ramp Slope (%)	5.0	
Yes	Ramp Width (in)	48.0	No	Ramp XSlope (%)	5.4	
N/A	Flare Type LT	N/A	N/A	Flare Type RT	N/A	
N/A	Flare Slope LT (%)	N/A	N/A	Flare Slope RT (%)	N/A	
N/A	Flare Traversable LT?	N/A	N/A	Flare Traversable RT?	N/A	
N/A	Landing Length (in)	N/A	N/A	DWS Provided?	N/A	
N/A	Landing Width (in)	N/A	N/A	DWS Contrast?	N/A	
N/A	Landing Slope (%)	N/A	N/A	DWS Length (in)	N/A	
N/A	Landing X Slope (%)	N/A	N/A	DWS Full Width?	N/A	
N/A	Landing Curb? (Y/N)	N/A	N/A	DWS Offset (in)	N/A	
N/A	Shared Landing?	N/A				
N/A	Gutter Ponding?	N/A	N/A	Gutter Slope (%)	N/A	
N/A	Gutter Lip Ht (in)	N/A	N/A	Gutter X Slope (%)	N/A	
N/A	Painted X Walk1?	Yes	N/A	Painted X Walk2?	No	
	X Walk 1 Direction	To NE		X Walk 2 Direction	To NW	
N/A	X Walk 1 Width (in)	110.0	N/A	X Walk 2 Width (in)	N/A

X Walk 1 Slope (%)	0.3		X Walk 2 Slope (%)	3.0	
	X Walk 1 X Slope (%)	4.0		X Walk 2 X Slope (%)	1.2	
N/A	Ramp inside XWalk1?	Yes	N/A	Ramp inside XWalk2?	N/A	
	Road Slope (%)	1.0	N/A	Clear Space?	N/A	
	Road X Slope (%)	2.3	N/A	Clear Space to XWalk (in)	N/A	
N/A	Any Obstructions?	N/A	N/A	Storm Grate/Utility Hazard?	N/A	
	Obstruction Type		l	Storm Grate/Utility Type		
		N/A			N/A	
			I		_

Remove & Replace Curb Ramp With Two New Directional Ramps or Equivalent.
