## Access Compliance Report Public Rights-of-Way (Curb Ramps)

Intersection ID: 18769	Main St	reet: BARCLAY_DOWNS_DR	Cross	Stroot				Location:	w	
					Cross Street: RUNNYMEDE_LN					
ADA ID: 8D9A0414B5C3	DA ID: 8D9A0414B5C3 Ramp Type: Perp			Initial Pass/Fail: Fail Overall Compliance: No				o Severity Score:	25	
Codes/Mitigation Info/Possible Solution				Field Measurements/Component Compliance						
		Possible Solutions:		Compliance Description Data C			Comp	Compliance Description Data		
1 Million and		Remove & Replace Entire Ramp	).	N/A	Ramp Length (in)	54.0	Yes	Ramp Slope (%)	5.6	
	Part and			Yes	Ramp Width (in)	48.0	No	Ramp XSlope (%)	11.0	
A CONTRACTOR	in 1			N/A	Flare Type LT	N/A	N/A	Flare Type RT	N/A	
A RUM	The state			N/A	Flare Slope LT (%)	N/A	N/A	Flare Slope RT (%)	N/A	
ALL	6 6			N/A	Flare Traversable LT?	N/A	N/A	Flare Traversable RT?	N/A	
LAN CONTRACTOR	5 <u>6</u>			N/A	Landing Length (in)	N/A	N/A	DWS Provided?	N/A	
	<u></u>	Surveyor Notes:		N/A	Landing Width (in)	N/A	N/A	DWS Contrast?	N/A

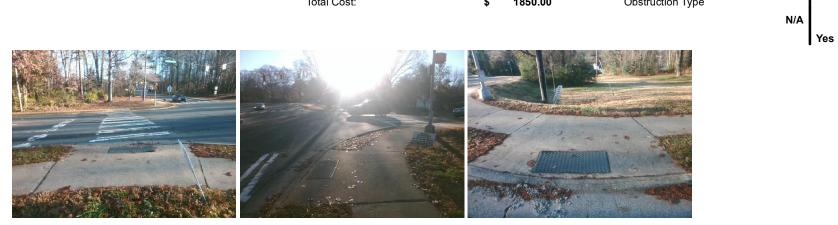
en e	101	N/A		N/A	Landing Slope (%)	N/A	N/A	DWS Length (in)	N/A	
				N/A	Landing X Slope (%)	N/A	N/A	DWS Full Width?	N/A	
	5			N/A	Landing Curb? (Y/N)	N/A	N/A	DWS Offset (in)	N/A	
5	6.			N/A	Shared Landing?	N/A				
	ALA STATE	PROW/ADA:		N/A	Gutter Ponding?	N/A	N/A	Gutter Slope (%)	N/A	
State State	11 Mars	Not Found, R304.5.3		N/A	Gutter Lip Ht (in)	N/A	N/A	Gutter X Slope (%)	N/A	
	and and	·		N/A	Painted X Walk1?	Yes	N/A	Painted X Walk2?	N/A	
SAGAMORE RD					X Walk 1 Direction	To NE		X Walk 2 Direction	N/A

6.				N/A	X Walk 1 Width (in)	114.0	N/A	X Walk 2 Width (in)	N/A	
Street 1 Name	RUNNYMEDE LN				X Walk 1 Slope (%)	5.6		X Walk 2 Slope (%)	N/A	
Stop Condition-Street 2	Signal				X Walk 1 X Slope (%)	7.1		X Walk 2 X Slope (%)	N/A	
Street 2 Name	N/A			N/A	Ramp inside XWalk1?	Yes	N/A	Ramp inside XWalk2?	N/A	
Stop Condition-Street 1	N/A				Road Slope (%)	N/A	N/A	Clear Space?	N/A	
					Road X Slope (%)	N/A	N/A	Clear Space to XWalk (in)	N/A	
				N/A	Any Obstructions?	N/A	N/A	Storm Grate/Utility Hazard?	N/A	
		Total Cost: \$	1850.00		Obstruction Type			Storm Grate/Utility Type		
						N/A			N/A
