Access Compliance Report

Public Rights-of-Way

(Curb Ramps)

Intersection ID: 27197	Main Street: BALLANTYNE COMMONS PY	Cross Street: CRESTWOOD DR	Location: SE
ADA ID: 8D9AB8D625CD	Ramp Type: Perp	Initial Pass/Fail: Fail	Overall Compliance: No
Severity Score: 22.5			
Codes/Mitigation Info/Possible Solution		Field Measurements/Component Compliance

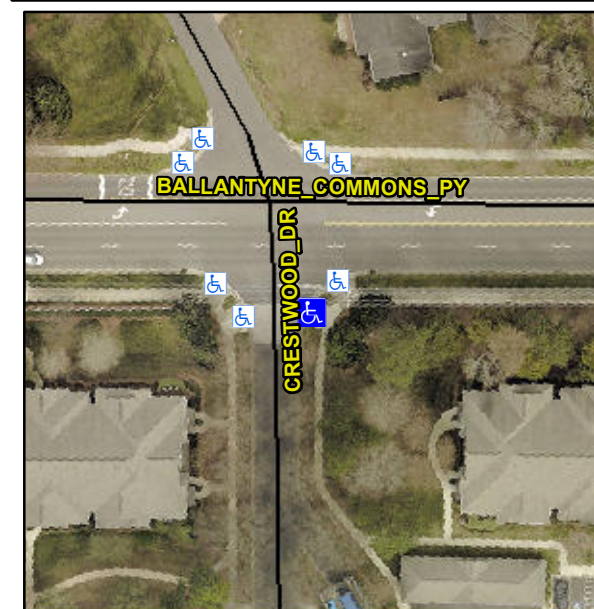
R304.5.1, R304.2.2, R304.5.3

Compliance	Description	Data	Compliance	Description	Data
N/A	Ramp Length (in)	98.0	No	Ramp Slope (%)	9.5
No	Ramp Width (in)	41.0	No	Ramp XSlope (%)	3.8
N/A	Flare Type LT	N/A	N/A	Flare Type RT	N/A
N/A	Flare Slope LT (%)	N/A	N/A	Flare Slope RT (%)	N/A
N/A	Flare Traversable LT?	N/A	N/A	Flare Traversable RT?	N/A
N/A	Landing Length (in)	N/A	N/A	DWS Provided?	N/A
N/A	Landing Width (in)	N/A	N/A	DWS Contrast?	N/A
N/A	Landing Slope (%)	N/A	N/A	DWS Length (in)	N/A
N/A	Landing X Slope (%)	N/A	N/A	DWS Full Width?	N/A
N/A	Landing Curb? (Y/N)	N/A	N/A	DWS Offset (in)	N/A
N/A	Shared Landing?	N/A			
N/A	Gutter Ponding?	N/A	N/A	Gutter Slope (%)	N/A
N/A	Gutter Lip Ht (in)	N/A	N/A	Gutter X Slope (%)	N/A
N/A	Painted X Walk1?	No	N/A	Painted X Walk2?	N/A
	X Walk 1 Direction	To W		X Walk 2 Direction	N/A
N/A	X Walk 1 Width (in)	N/A	N/A	X Walk 2 Width (in)	N/A
	X Walk 1 Slope (%)	0.4		X Walk 2 Slope (%)	N/A
	X Walk 1 X Slope (%)	4.2		X Walk 2 X Slope (%)	N/A

Possible Solutions:

Remove & Replace Entire Ramp.
