Access Compliance Report

Public Rights-of-Way

(Curb Ramps)

Intersection ID: N/A	Main Street: REMOUNT_RD	Cross Street: I-77_EXIT_8	Location: SW
ADA ID: 8DA2260C9926	Ramp Type: Directional2	Initial Pass/Fail: Fail	Overall Compliance: No
		Severity Score: 22.5

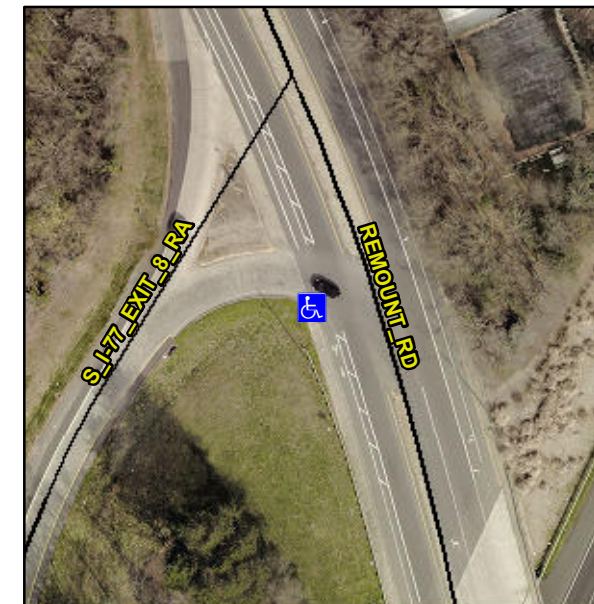
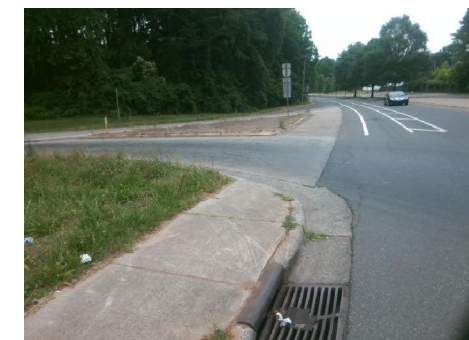
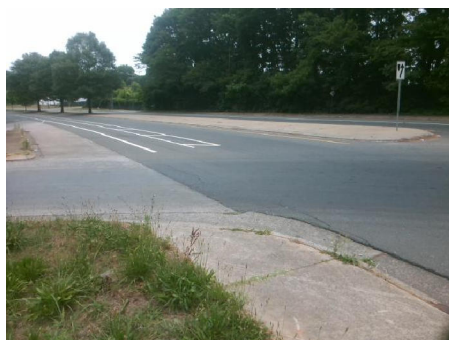
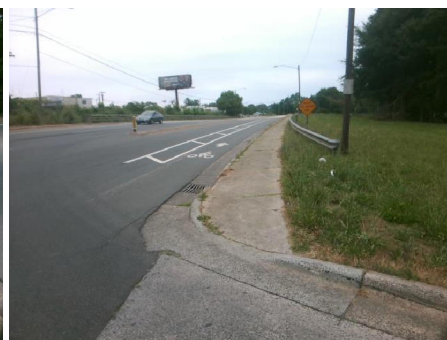
Compliance	Description	Data	Compliance	Description	Data
N/A	Ramp Length (in)	64.0	N/A	Grade Break?	N/A
No	Ramp Width (in)	41.0	N/A	Grade Break Slope (%)	0.0
No	Ramp Slope (%)	11.5	N/A	Grade Break XSlope (%)	0.0
Yes	Ramp XSlope (%)	2.4			
N/A	Flare Type LT	N/A	N/A	Flare Type RT	N/A
N/A	Flare Slope LT (%)	N/A	N/A	Flare Slope RT (%)	0.0
N/A	Flare Traversable LT?	N/A	N/A	Flare Traversable RT?	N/A
N/A	Landing Length (in)	0.0	N/A	DWS Provided?	N/A
N/A	Landing Width (in)	0.0	N/A	DWS Contrast?	N/A
N/A	Landing Slope (%)	0.0	N/A	DWS Length (in)	N/A
N/A	Landing X Slope (%)	0.0	N/A	DWS Full Width?	N/A
N/A	Landing Curb? (Y/N)	N/A	N/A	DWS Offset LT (in)	N/A
N/A	Shared Landing?	N/A	N/A	DWS Offset RT (in)	N/A
N/A	Gutter Ponding?	0.0	N/A	Gutter Slope (%)	N/A
N/A	Gutter Lip Ht (in)	0.0	N/A	Gutter X Slope (%)	N/A
N/A	Painted X Walk1?	No		Road Slope (%)	4.2
	X Walk 1 Direction	To N		Road X Slope (%)	3.5
	X Walk 1 Width (in)	N/A		Clear Space?	N/A

X Walk 1 Slope (%)	4.2	N/A	Clear Space to XWalk (in)	N/A
	X Walk 1 X Slope (%)	3.5	N/A	Storm Grate/Utility Hazard?	N/A
N/A	Ramp inside XWalk1?	N/A		Storm Grate/Utility Type	
N/A	Any Obstructions?	N/A			N/A
	Obstruction Type		Yes	Surface Condition? (G/P)	Good
			N/A	Curb Slope (%)	18.0

Remove & Replace Entire Ramp.
