# Access Compliance Report

## Public Rights-of-Way

### (Curb Ramps)

Intersection ID: 29769	Main Street: BRAMBLE_CREEK_DR	Cross Street: FAWN_HILL_RD	Location: W
ADA ID: 8DA3DA894035	Ramp Type: PerpDiag	Initial Pass/Fail: Fail	Overall Compliance: No
Severity Score: 8.75			
Codes/Mitigation Info/Possible Solution		Field Measurements/Component Compliance

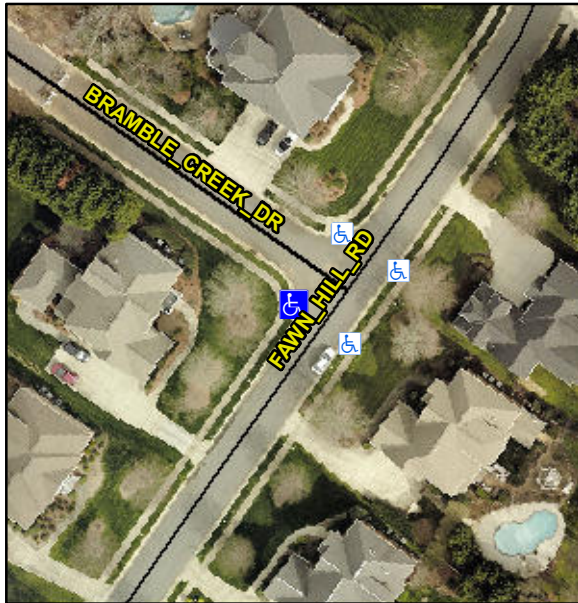
**Not Found, R304.5.1**

Compliance	Description	Data	Compliance	Description	Data
N/A	Ramp Length (in)	46.0	Yes	Ramp Slope (%)	7.3
No	Ramp Width (in)	44.5	Yes	Ramp XSlope (%)	1.0
N/A	Flare Type LT	N/A	N/A	Flare Type RT	N/A
N/A	Flare Slope LT (%)	N/A	N/A	Flare Slope RT (%)	N/A
N/A	Flare Traversable LT?	N/A	N/A	Flare Traversable RT?	N/A
N/A	Landing Length (in)	N/A	N/A	DWS Provided?	N/A
N/A	Landing Width (in)	N/A	N/A	DWS Contrast?	N/A
N/A	Landing Slope (%)	N/A	N/A	DWS Length (in)	N/A
N/A	Landing X Slope (%)	N/A	N/A	DWS Full Width?	N/A
N/A	Landing Curb? (Y/N)	N/A	N/A	DWS Offset (in)	N/A
N/A	Shared Landing?	N/A			
N/A	Gutter Ponding?	N/A	N/A	Gutter Slope (%)	N/A
N/A	Gutter Lip Ht (in)	N/A	N/A	Gutter X Slope (%)	N/A
N/A	Painted X Walk1?	No	N/A	Painted X Walk2?	No
	X Walk 1 Direction	To SE		X Walk 2 Direction	To NE
N/A	X Walk 1 Width (in)	N/A	N/A	X Walk 2 Width (in)	N/A
	X Walk 1 Slope (%)	1.9		X Walk 2 Slope (%)	2.2
	X Walk 1 X Slope (%)	2.5		X Walk 2 X Slope (%)	1.9

**Remove & Replace Curb Ramp With Two New Directional Ramps or Equivalent.**

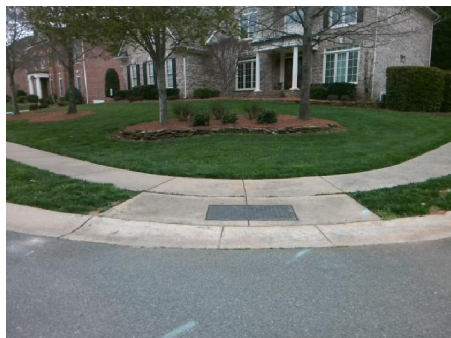
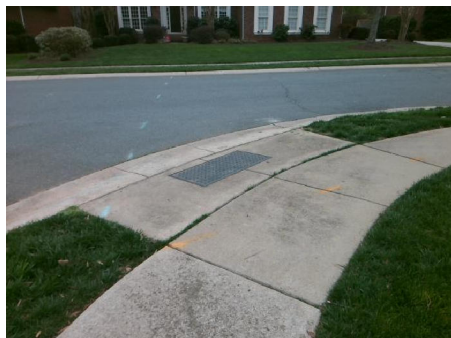
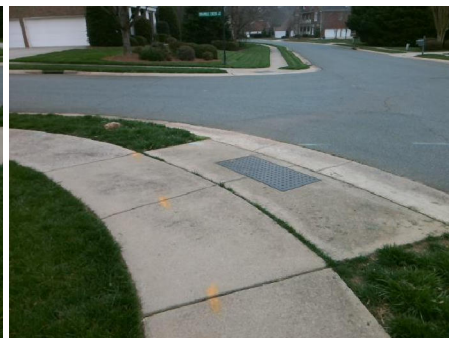
N/A	Ramp inside XWalk1?	N/A	N/A	Ramp inside XWalk2?	N/A
	Road Slope (%)	0.3	N/A	Clear Space?	N/A
	Road X Slope (%)	1.2	N/A	Clear Space to XWalk (in)	N/A
N/A	Any Obstructions?	N/A	N/A	Storm Grate/Utility Hazard?	N/A
	Obstruction Type			Storm Grate/Utility Type	
		N/A			N/A
			Yes	Surface Condition? (G/P)	Good
