# Access Compliance Report

## Public Rights-of-Way

### (Curb Ramps)

Intersection ID: 43204	Main Street: PLANTAIN_CT	Cross Street: SPEEDWELL_CT	Location: SE
ADA ID: 8DA909EDFA20	Ramp Type: PerpDiag	Initial Pass/Fail: Fail	Overall Compliance: No
Severity Score: 22.5			
Codes/Mitigation Info/Possible Solution		Field Measurements/Component Compliance

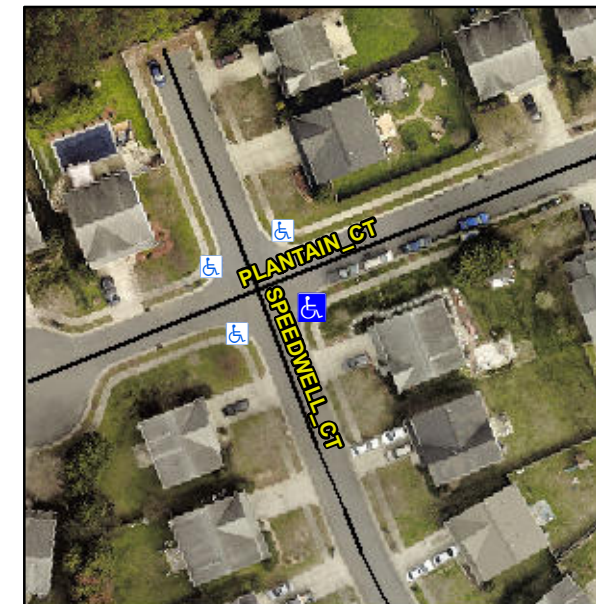
Compliance	Description	Data	Compliance	Description	Data
N/A	Ramp Length (in)	49.0	No	Ramp Slope (%)	10.2
No	Ramp Width (in)	37.0	No	Ramp XSlope (%)	3.5
N/A	Flare Type LT	N/A	N/A	Flare Type RT	N/A
N/A	Flare Slope LT (%)	N/A	N/A	Flare Slope RT (%)	N/A
N/A	Flare Traversable LT?	N/A	N/A	Flare Traversable RT?	N/A
N/A	Landing Length (in)	N/A	N/A	DWS Provided?	N/A
N/A	Landing Width (in)	N/A	N/A	DWS Contrast?	N/A
N/A	Landing Slope (%)	N/A	N/A	DWS Length (in)	N/A
N/A	Landing X Slope (%)	N/A	N/A	DWS Full Width?	N/A
N/A	Landing Curb? (Y/N)	N/A	N/A	DWS Offset (in)	N/A
N/A	Shared Landing?	N/A			
N/A	Gutter Ponding?	N/A	N/A	Gutter Slope (%)	N/A
N/A	Gutter Lip Ht (in)	N/A	N/A	Gutter X Slope (%)	N/A
N/A	Painted X Walk1?	No	N/A	Painted X Walk2?	No
	X Walk 1 Direction	To N		X Walk 2 Direction	To W
N/A	X Walk 1 Width (in)	N/A	N/A	X Walk 2 Width (in)	N/A
	X Walk 1 Slope (%)	6.5		X Walk 2 Slope (%)	2.1
	X Walk 1 X Slope (%)	2.8		X Walk 2 X Slope (%)	2.4

N/A	Ramp inside XWalk1?	N/A	N/A	Ramp inside XWalk2?	N/A
	Road Slope (%)	3.4	N/A	Clear Space?	N/A
	Road X Slope (%)	4.7	N/A	Clear Space to XWalk (in)	N/A
N/A	Any Obstructions?	N/A	N/A	Storm Grate/Utility Hazard?	N/A
	Obstruction Type			Storm Grate/Utility Type	
		N/A			N/A
			Yes	Surface Condition? (G/P)	Good

Possible Solutions:

**Remove & Replace Curb Ramp With Two New Directional Ramps or Equivalent.**

**Not Found, R304.5.1, R304.2.2, R304.5.3**
