Access Compliance Report

Public Rights-of-Way

(Curb Ramps)

Intersection ID: 12629	Main Street: E_6TH_ST	Cross Street: N_DAVIDSON_ST	Location: NE
ADA ID: 8DAA2298703E	Ramp Type: Perp	Initial Pass/Fail: Fail	Overall Compliance: No
Severity Score: 22.5			
Codes/Mitigation Info/Possible Solution		Field Measurements/Component Compliance

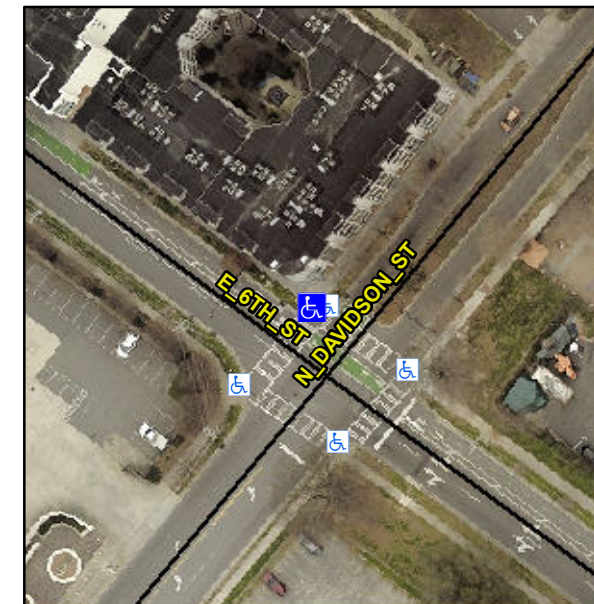
Not Found, R304.5.1, R304.2.2, R304.5.3

Compliance	Description	Data	Compliance	Description	Data
N/A	Ramp Length (in)	68.5	No	Ramp Slope (%)	8.4
No	Ramp Width (in)	47.0	No	Ramp XSlope (%)	5.0
N/A	Flare Type LT	N/A	N/A	Flare Type RT	N/A
N/A	Flare Slope LT (%)	N/A	N/A	Flare Slope RT (%)	N/A
N/A	Flare Traversable LT?	N/A	N/A	Flare Traversable RT?	N/A
N/A	Landing Length (in)	N/A	N/A	DWS Provided?	N/A
N/A	Landing Width (in)	N/A	N/A	DWS Contrast?	N/A
N/A	Landing Slope (%)	N/A	N/A	DWS Length (in)	N/A
N/A	Landing X Slope (%)	N/A	N/A	DWS Full Width?	N/A
N/A	Landing Curb? (Y/N)	N/A	N/A	DWS Offset (in)	N/A
N/A	Shared Landing?	N/A			
N/A	Gutter Ponding?	Yes	N/A	Gutter Slope (%)	N/A
N/A	Gutter Lip Ht (in)	N/A	N/A	Gutter X Slope (%)	N/A
N/A	Painted X Walk1?	Yes	N/A	Painted X Walk2?	N/A
	X Walk 1 Direction	To SW		X Walk 2 Direction	N/A
N/A	X Walk 1 Width (in)	108.5	N/A	X Walk 2 Width (in)	N/A
	X Walk 1 Slope (%)	6.5		X Walk 2 Slope (%)	N/A
	X Walk 1 X Slope (%)	2.0		X Walk 2 X Slope (%)	N/A

N/A	Ramp inside XWalk1?	Yes	N/A	Ramp inside XWalk2?	N/A
	Road Slope (%)	N/A	N/A	Clear Space?	N/A
	Road X Slope (%)	N/A	N/A	Clear Space to XWalk (in)	N/A
N/A	Any Obstructions?	N/A	N/A	Storm Grate/Utility Hazard?	N/A
	Obstruction Type			Storm Grate/Utility Type	
		N/A			N/A
		Yes		Surface Condition? (G/P)	Good

Possible Solutions:

Remove & Replace Entire Ramp.
