Access Compliance Report Public Rights-of-Way (Curb Ramps)

Intersection ID: N/A	Main Street: WENDOVER RD	Cross Street: N/A	Location: SE
ADA ID: 8DACCAA33EA0	Ramp Type: BlendTrans2	Initial Pass/Fail: Fail	Overall Compliance: No Severity Score: 21.25

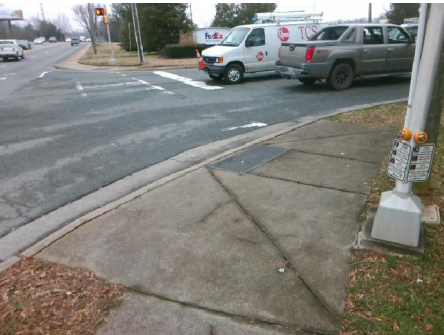
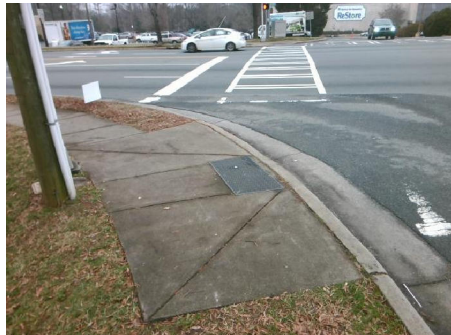
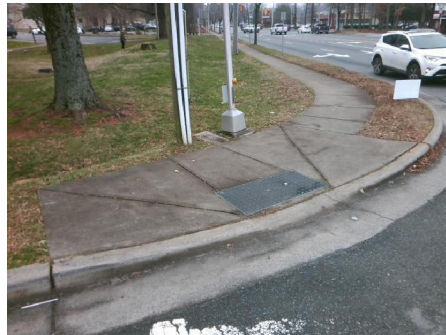
Not Found, R304.5.1, R304.5.3

Compliance	Description	Data	Compliance	Description	Data
N/A	Ramp Length (in)	82.0	Yes	BlendTrans Slope (%)	3.2
No	Ramp Width (in)	37.0	No	BlendTrans XSlope (%)	6.8
N/A	Flare Type LT	N/A	N/A	Flare Type RT	N/A
N/A	Flare Slope LT (%)	N/A	N/A	Flare Slope RT (%)	N/A
N/A	Flare Traversable LT?	N/A	N/A	Flare Traversable RT?	N/A
N/A	Landing Length (in)	N/A	N/A	DWS Provided?	N/A
N/A	Landing Width (in)	N/A	N/A	DWS Contrast?	N/A
N/A	Landing Slope (%)	N/A	N/A	DWS Length (in)	N/A
N/A	Landing X Slope (%)	N/A	N/A	DWS Full Width?	N/A
N/A	Landing Curb? (Y/N)	N/A	N/A	DWS Offset (in)	N/A
N/A	Shared Landing?	N/A			
N/A	Gutter Ponding?	N/A	N/A	Gutter Slope (%)	N/A
N/A	Gutter Lip Ht (in)	N/A	N/A	Gutter X Slope (%)	N/A
N/A	Painted X Walk1?	Yes	N/A	Painted X Walk2?	Yes
	X Walk 1 Direction	To NE		X Walk 2 Direction	To NW
	X Walk 1 Width (in)	106.0		X Walk 2 Width (in)	101.0
	X Walk 1 Slope (%)	2.2		X Walk 2 Slope (%)	3.4
	X Walk 1 X Slope (%)	3.4		X Walk 2 X Slope (%)	4.2

N/A	Ramp inside XWalk1?	Yes	N/A	Ramp inside XWalk2?	Yes
	Road Slope (%)	3.5		Clear Space?	N/A
	Road X Slope (%)	0.9	N/A	Clear Space to XWalk (in)	N/A
N/A	Any Obstructions?	N/A	N/A	Storm Grate/Utility Hazard?	N/A
	Obstruction Type			Storm Grate/Utility Type	
		N/A			N/A
			Yes	Surface Condition? (G/P)	Good
			No	Curb Slope (%)	17.4

Remove & Replace Curb Ramp With Two New Directional Ramps or Equivalent.

Total Cost: \$ **3200.00**
